Appraisal of Existing River Protections in Kassala Town

Adam Khalifa Mohammed Khalifa¹, Abbas Abdalla Ebrahim², Elsadig Elhadi Elhassan³

College of Water and Environmental Engineering, Sudan University of Science and Technology (SUST)¹
School of Civil Engineering, Sudan University of Science and Technology (SUST)³

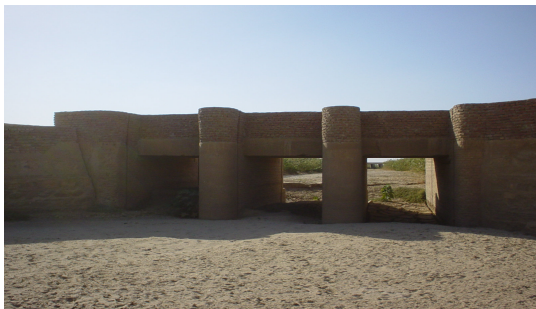
Figure 9: Photo of old bridge during 2003 flood

It became apparent that the Gash River poses the biggest potential danger to lives, properties and livelihoods in the area. The flood of the Gash River in 2003 breached its banks. This resulted in the Gash River changing its course to the centre of Kassala Town, causing extensive losses of lives, properties and injuring several persons. At least 600 buildings were swept away and the old bridge was completely submerged. The flood damaged 70% of the town, affecting

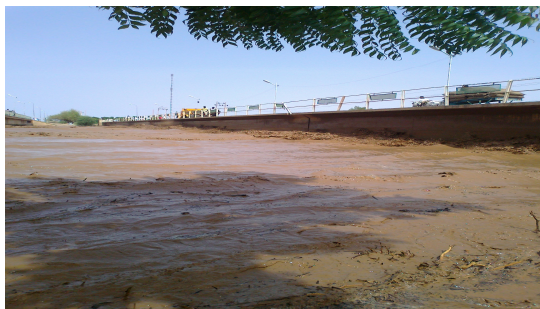
Figure 10: Futa off take and gauge

- Pitched Spurs Futa Reach is an extension to the downstream pitched spurs reach of Figure 6. It lies further downstream to the north of Kassala Town.Futa off take with its Gauging Station was maintained to remain in tact as shown in Figure 10.

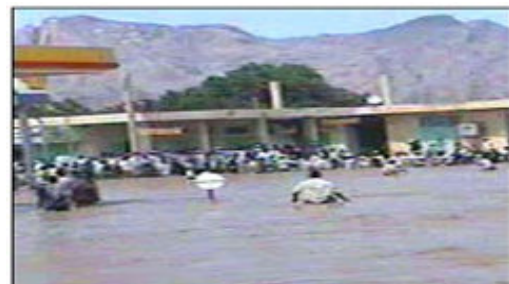
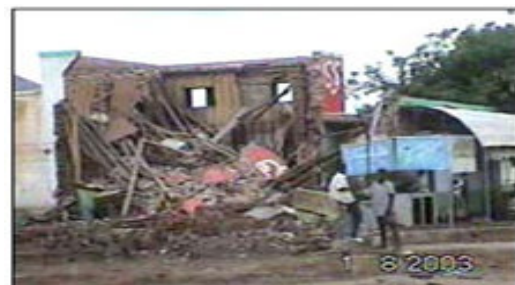
Figure 13: Disastrous Flood of 2003

These rainstorms, although not up normal, yet were reported that they caused damage to about **670** houses. It was also reported that the highest instantaneous gauge level and discharge that ever observed at Kassala was that of the 30th of July 2003. The reported out come of that flood were the immediate occurrence of seven breaches on both sides of the river; four in the east and three on the west.

The town market, central hospital, and many other governmental utilities were also inundated. The tragedy included **6** deaths and **60** wounded. It was reported that the losses in residences was about twenty thousand houses; in the marketing area over eight hundred units; governmental health, public and educational utilities more than **160** units. The total loss of the public and private sectors was reported to approach **150 billion** Sudanese Dinnars (**575** million U.S.Dollars). Some of the pathetic sceneries are shown in Figure 13. River training for the protection of the town, which goes back to 1905, was worked out along intermittent and short lived approaches. The absence of long-term plans is greatly responsible for the present complex problems.

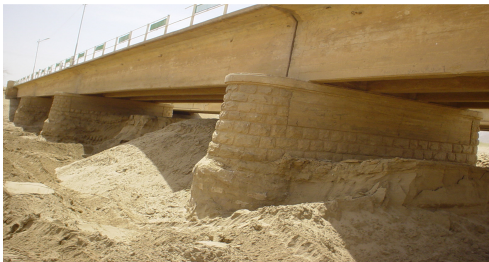
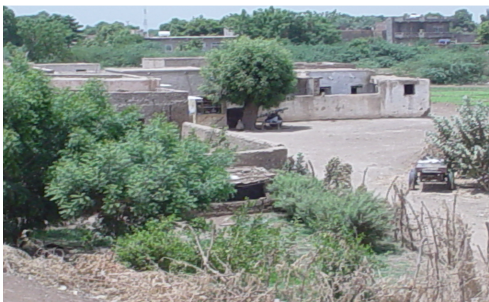
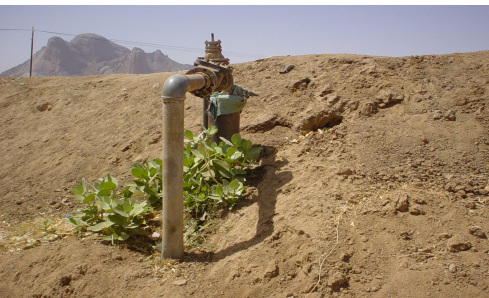
Figure 14: Typical example of undesired activities

In 1975 it was observed that many undesired activities were conducted in the flood plain. Lined irrigation channels, residential houses, were built on the top the middle and the side slope of the protection banks. Irrigation wells and pit latrines as well as brick quarries were dug adjacent to the banks. Similar undesired activities were observed in the banks adjacent to Kassala town. Figure 14 depict some undesired
