Maintenance and Rehabilitation of Masonry Structures

A Thesis Submitted in Partial Fulfillment of the Requirements for the
Degree of Master in Civil Engineering (Construction Engineering)

Zeinab Hassan Bakri Hamad

March 2018

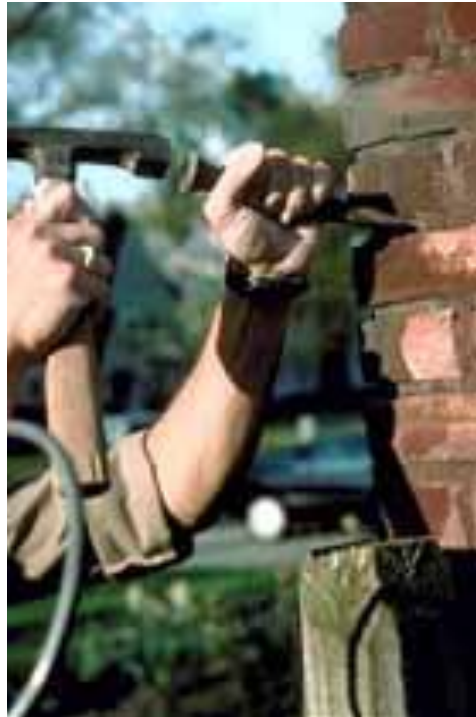
Figure 2.4: A hammer and chisel are being correctly used to prepare a joint for repointing

To prepare the joint, old mortar should be removed to a depth of at least twice the joint width, or until sound mortar is reached. In historic structures with thin mortar joints, the power tools typically used for this purpose can damage the masonry units by overcutting. Hand chisels and, when necessary, small pneumatic grinders, present the least threat to masonry units as shown in **Figure 2.4**. Loose mortar must then be flushed or brushed from the joint.

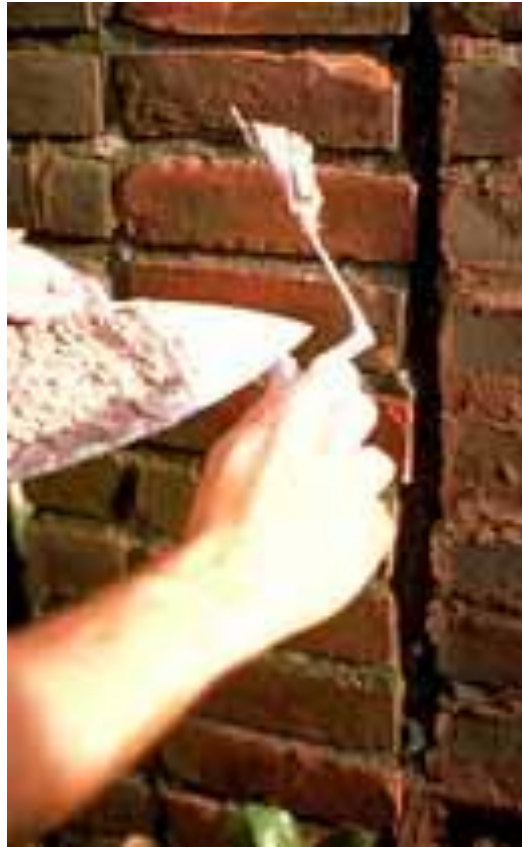
Figure 2.5: Soft mortar for repointing

Once mortar has been selected and the joint prepared, mortar should be pre-hydrated and then packed into the joint in thin layers as seen in **Figure 2.5**. Like most mortar shrinkage occurs during the hardening process, allowing each layer time to harden before the next is applied minimizes overall shrinkage.

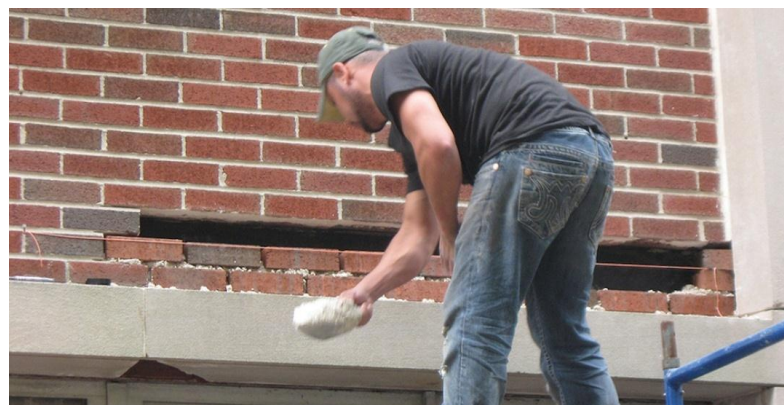
Figure 2.6 Bricks replacement

Severely spalled or damaged masonry units should be replaced with units selected to match the originals in color, dimensions, and texture as illustrated in **Figure 2.6**. After the damaged units have been removed from the wall, all of the existing mortar should be cleared away and the surface cleaned and prepared. With the appropriate surfaces buttered with new mortar, replacement units should be pressed into position and joints fully pointed and tooled. As with repointing, mortar for masonry unit replacement should be selected to match the existing mortar in properties and appearance.^[7]

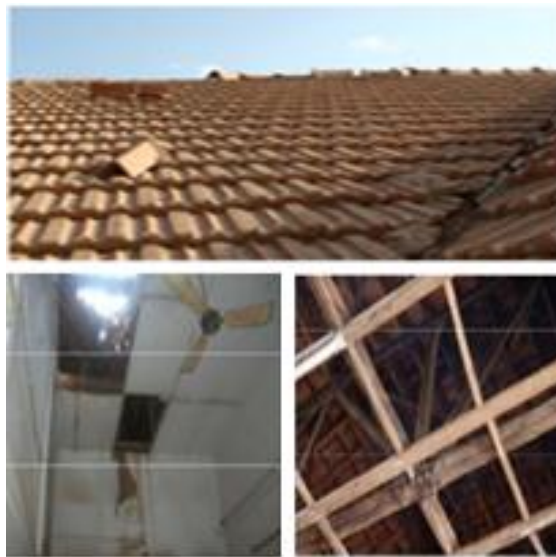
Figure 3.3: Internal and external view of damaged roofs ^[16]

1. Missing and slipped tiles of roof, so this was caused damage of internal roofs as shown in **Figure 3.3**

To stiffen and strengthen the roof diaphragm, one can adopt an intervention that is compatible with the original timber structure by replacing the damaged members and add insulator layer before fix roof tiles as seen in **Figure 4.7**.

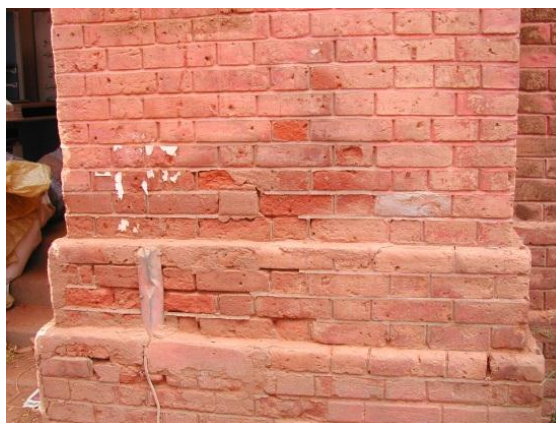
Figure 3.4(a): Disintegrating mortar ^[16]

2. Disintegrating mortar, cracks, loose masonry units and damp walls. Also walls suffer from growth of some plants and distortion the façade by coating. **Figures** from 3.4(a) to 3.4(e) demonstrate the problems.

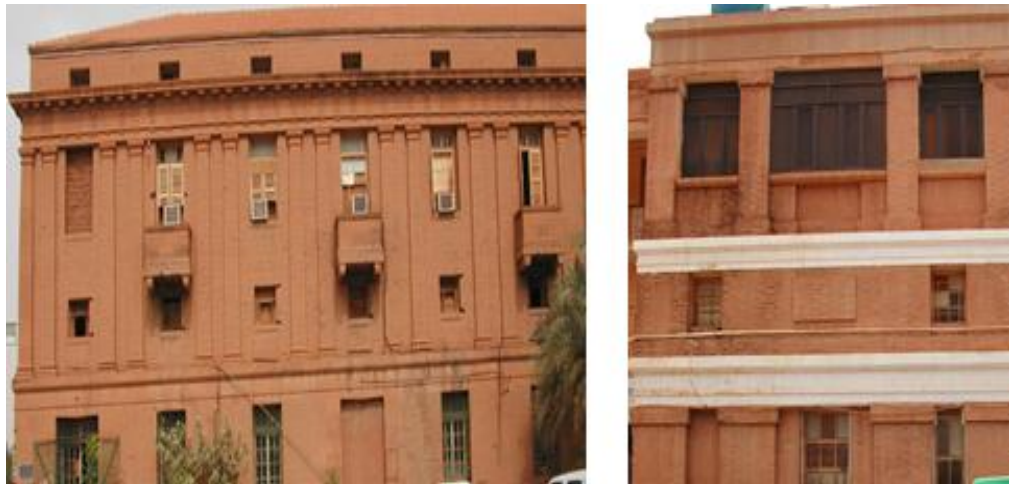
Figure 3.5: Nonconformance windows' materials ^[16]

3. Most of the windows and doors are damages partially or completely and others are replaced by modern materials. Also some others are closed by brickwork as presents in **Figure 3.5**

5. The maintenance tasks associated with windows and doors will involve ensuring they remain weather tight and operational and that the different materials of timber or metal, glass and putty are kept in good condition. The external windows will be double as they are, the external unit will be timber and the internal unit will be metal with glasses which are the same design in the past. Also the doors and internal windows will be metal with glass as they are. **Figure 4.6** shows the maintenance of internal doors and windows.

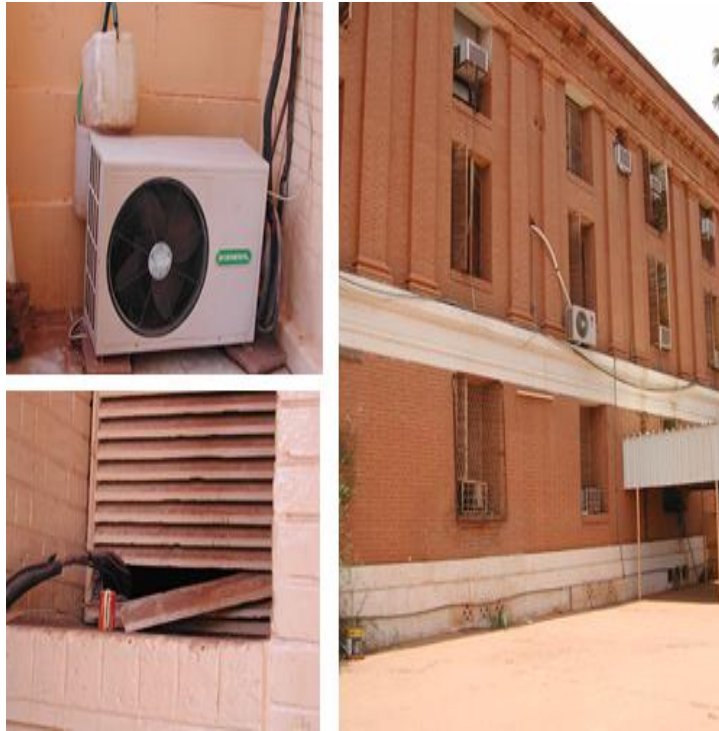
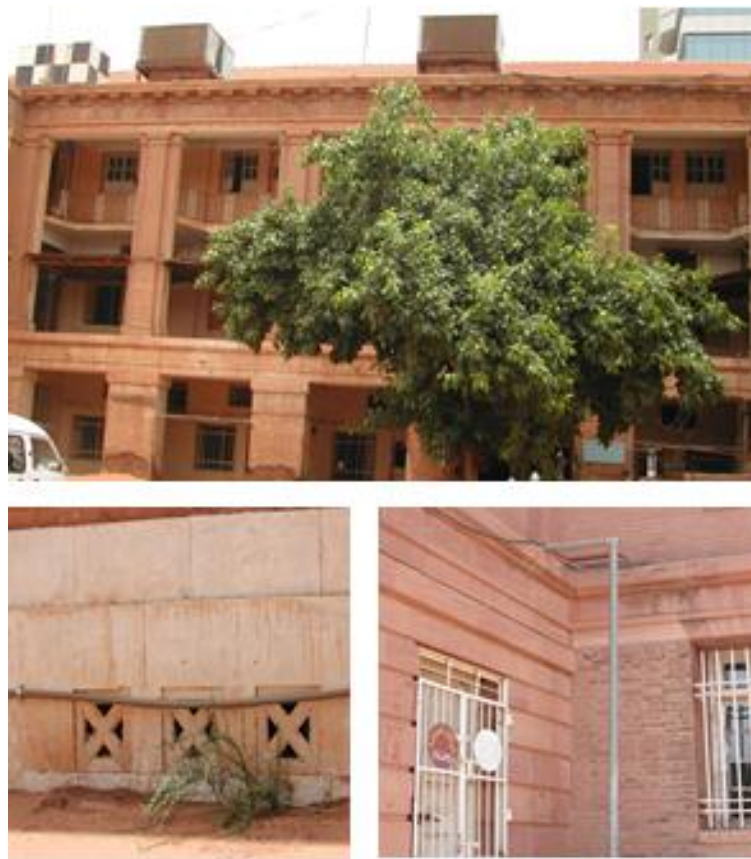
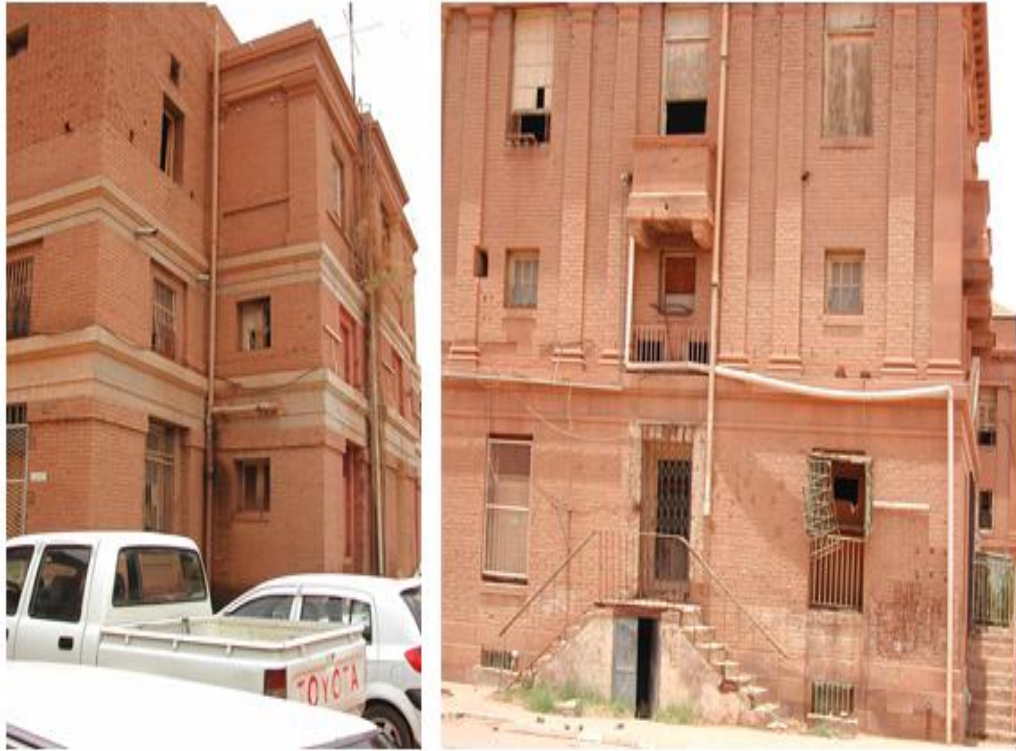
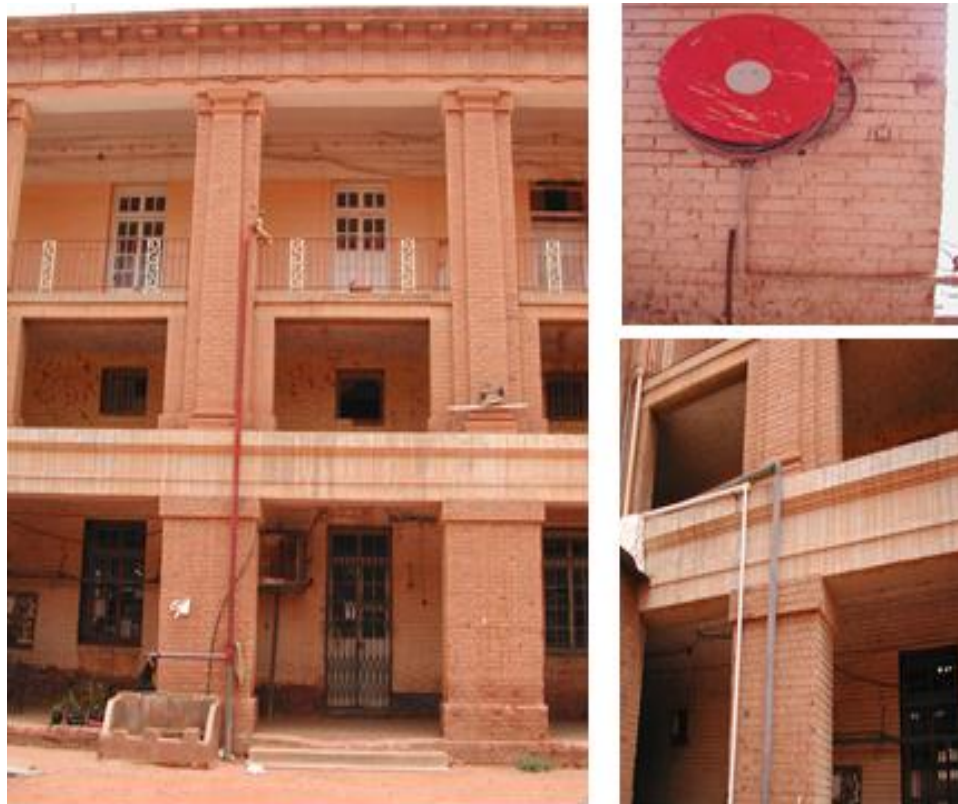
4. The building's essential services (such as cooling, water, sewage, firefighting, electricity, cabling) connected by scattered way, which deformed outer appearance of the building as illustrated in the **Figures 3.6**.

Figure 3.6(a): Scattered way for connecting cooling ^[16]

Figure 3.6(b): Scattered way for connecting water ^[16]

Figure 3.6(c): Scattered way for connecting sewage ^[16]

Figure 3.6(d): Scattered way for connecting firefighting ^[16]

- Replace the outside bathrooms by new bathrooms inside the building by build new wall inside the specific area as cladding to install connections.
- Install the electricity and data services networks inside walls as illustrated in **Figure4.5**.
- Change the cooling system to a center cooling to avoid the units on facades. Also add glasses curtain walls at halls to safe cooling inside.
- Replace the water's tanks with anther in hidden place.

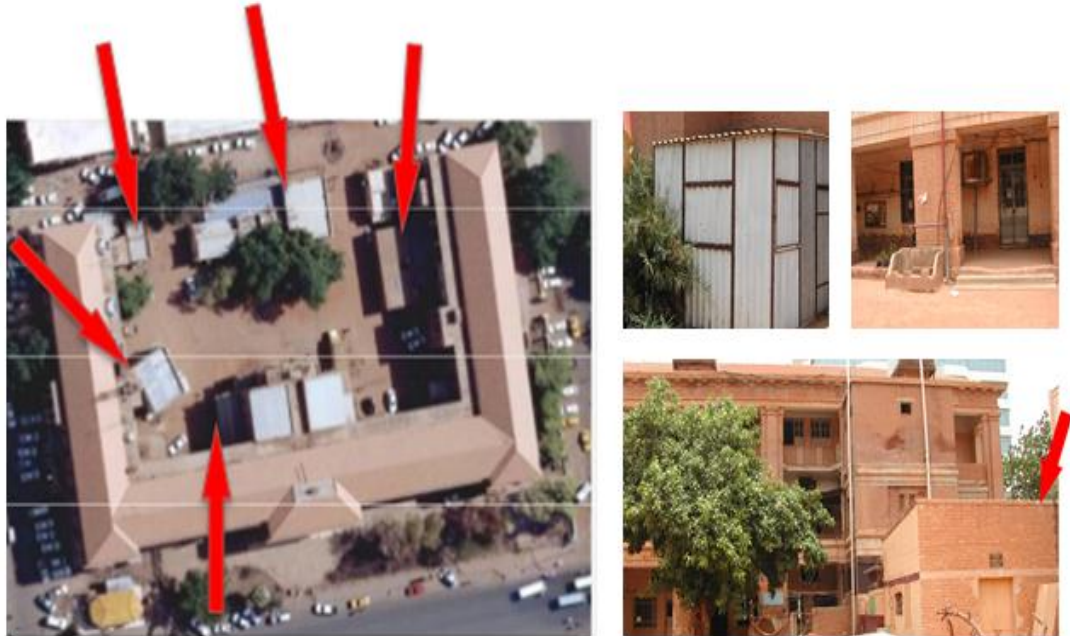
Figure 3.7: Random elements obscure the main building

5. Added random extraneous elements, which lost the building its general essence as shown in **Figure 3.7**

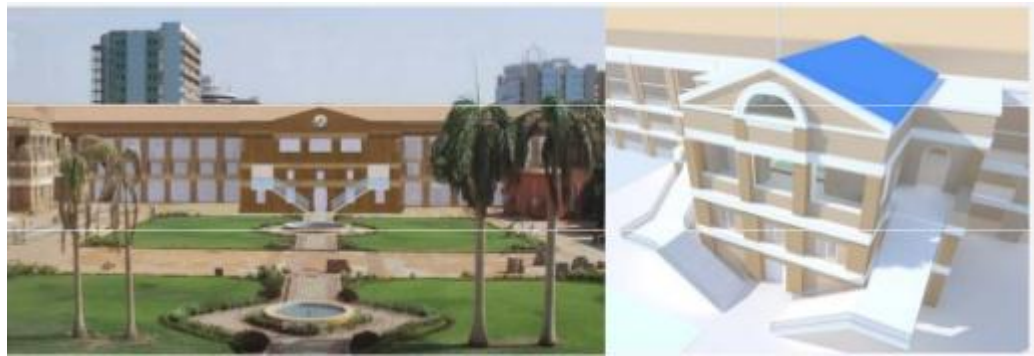
Figure 4.3(a): New stairs and elevators at the main north entrance ^[16]

3. To evaluate the relative importance of the various spaces, the assessment should identify architectural features and finishes that are part of the interior's history and character. So it is useful to add elevators and stairs without cause any damage to the main building. Installing permanent partitions in secondary spaces and making use of demountable partitions, when subdivision of a character-defining space is required to accommodate a new use as shown in **Figures 4.3(a), 4.3(b) and 4.4.**

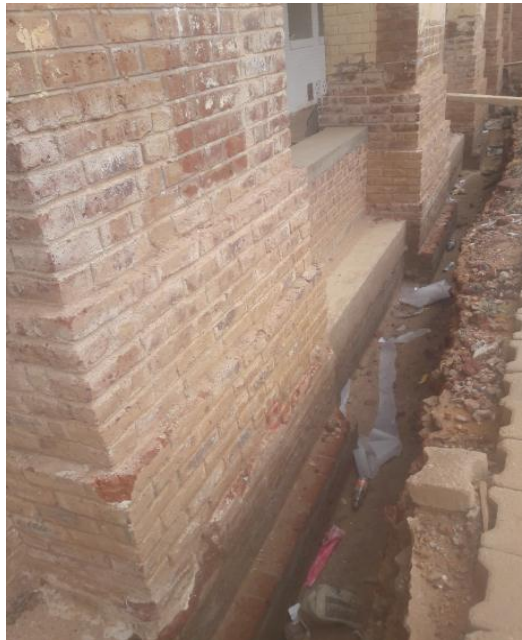
Figure 4.8: Excavate foundations for maintenance

injected, maintained damage and covered foundations to caulked voids as shown in **Figure 4.8**.

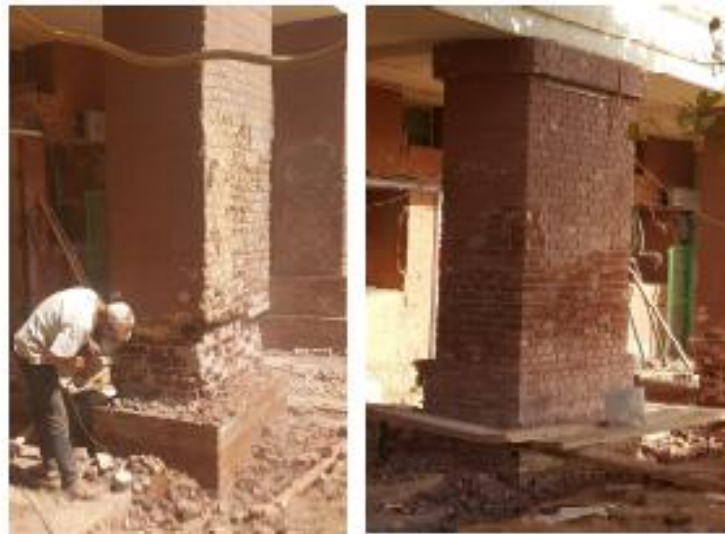
Figure 4.9: Bricks replacement in columns ^[15]

- The new mortar must have greater vapor permeability and be softer (measured in compressive strength) than the masonry units.
4. Protecting and maintaining interior and exterior features through appropriate repairs to their functional parts and by using appropriate surface treatments, such as cleaning, rust removal, limited paint removal and reapplying protective coating systems in kind.
