# **Assessment of Curtain Grouting Used in the Foundation Treatment at Dam Complex of Upper Atbara River**

A Thesis Submitted in Partial Fulfillment for the Degree of Master  
of Construction Engineering at Sudan University of Sciences and  
Technology

July 2019

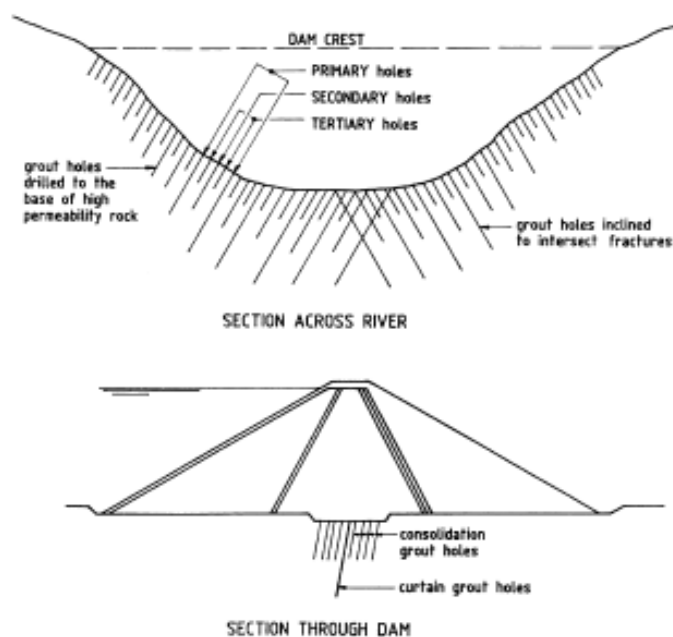
**Figure 1-3** An example of embankment dam foundation grouting.

The foundations for most dams more than 15 m high built on rock, and for some which are smaller, are treated by grouting. Grouting consists of drilling a line or lines of holes from the cutoff level of the dam into the dam foundation and forcing cement slurry, or chemicals under pressure into the rock defects, that is joints, fractures, bedding partings and faults. Figure 1.3 shows an example:

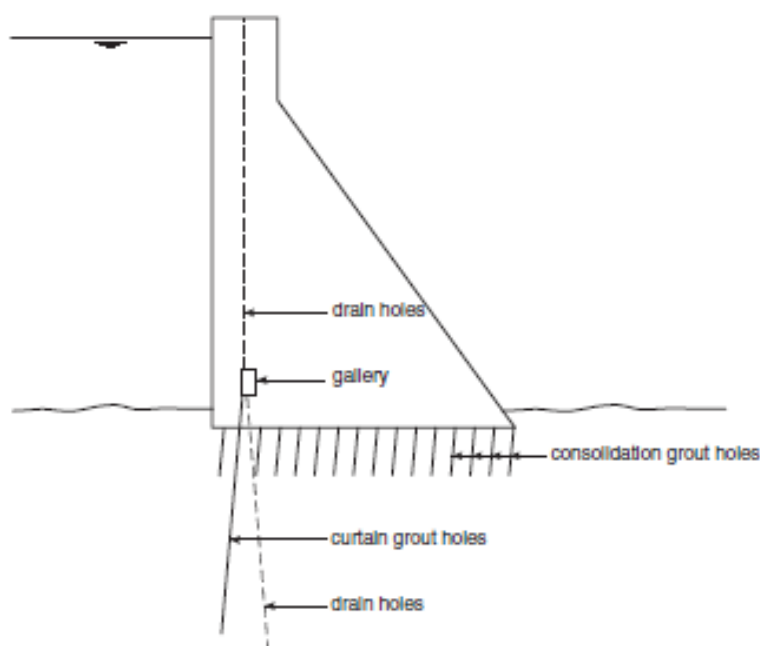
**Figure 1-4** Curtain and consolidation grouting for concrete gravity dams.

Figure 1-4 shows a section through a concrete gravity dam. The curtain grouting is located near the upstream face of the dam and usually carried out from a gallery in the dam; sometimes from the upstream heel of the dam. It is designed to reduce seepage through the foundations and, in conjunction with the borehole drain holes, to control uplift pressures.

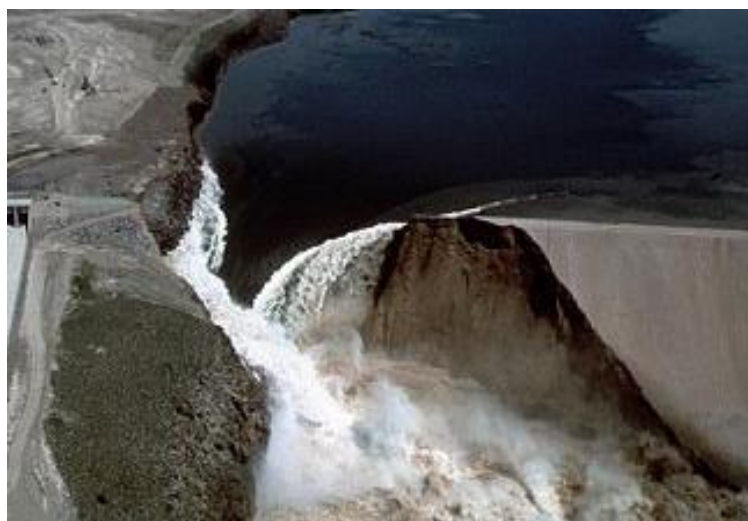
**Figure 2-1:** Teton Earthen Dam Failure in 1976 (Arthur, 1977).

The seepage through the earthen dam caused structural degradation ultimately leading to the breach of the dam. Tremendous damage resulted in the breach of the Teton Earthen Dam. Significant flooding occurred in the communities just downstream of the dam. Damages were estimated to be nearly one billion dollars. Unfortunately, the flooding due to the breach of the dam claimed 14 lives. As can be seen, groundwater seepage under dams can introduce significant issues to the structural integrity of dams and other impoundments.

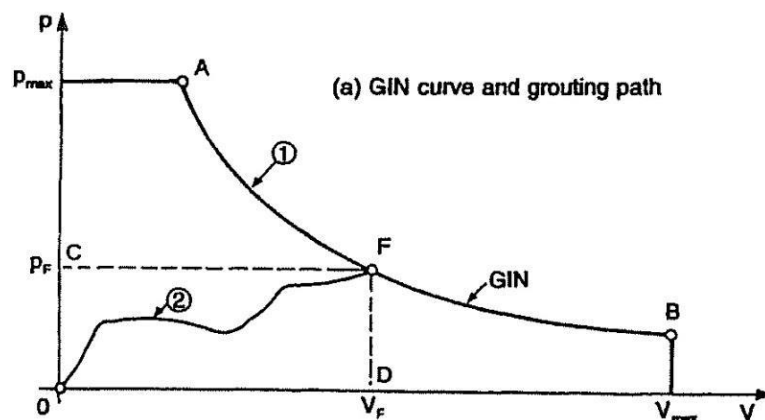
**Figure 2-2:** Grouting process of a single borehole

- 1- The GIN-Method: according to LOMBARDI (2003) “the fundamental principle of the GIN-Method (GIN: Grouting Index Number) is to reduce the grouting pressure as a function of the volume of grout injected”. The aim of this method is to limit the losses of grout material, simplify the grouting procedure, save the cost of unnecessary permeability tests and reduce the risk of hydro-jacking and hydro-fracturing. A maximum pressure, a maximum volume of grouting and the GIN (a maximum intensity), curve determine the limits of the grouting procedure. The monitoring during the execution of the grouting works allows knowing when these limits are reached, and then the process is stopped. It can be presented as following in the Figure 2-2.

- (1) Limiting curve, (2) actual grouting path, (F) final point of the grouting, ( $P_F$ ) final grout pressure, ( $V_F$ ) actual grout take, [LOMBARDI, 2003]
- 2- The U.S. practice: it indicates that the injection pressure should be set relative to the overlying rock thereby:

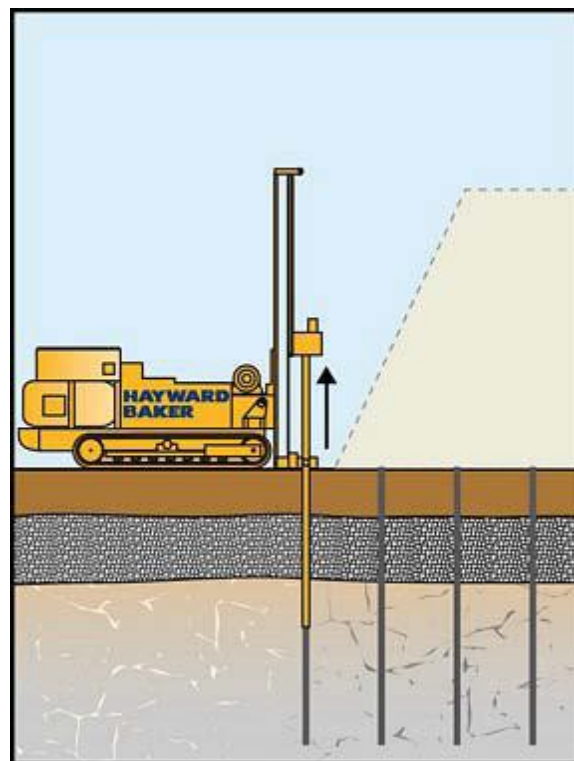
**Figure 2-4:** Illustration of the high-mobility grouting technique (Hayward Baker, 2014).

High-mobility grouting uses the flow of a pressurized cementitious grout material. Over time, the grouting material enters into the crevices of the underlying soil causing the grout and soil to bind together. Figure 2-4 presents the high-mobility grouting technique.

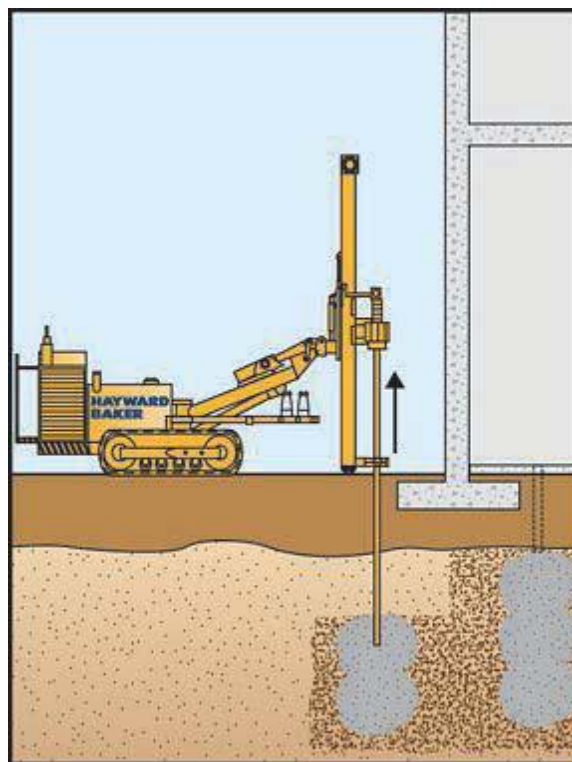
**Figure 2-5:** Compaction grouting technique (Hayward Baker, 2014).

Also, compaction grouting is performed to stabilize large void spaces known as sinkholes by using a low-mobility grout mixture (Hayward Baker, 2014). The pressurized grout is injected into the ground by a pipe. As the grout is continuously injected, the pipe is slowly raised, forming a bulb like structure. For further clarity refer to Figure 2-5, which illustrates the compaction grouting technique.

The injected grout displaces the loose surrounding material. During the displacement and expansion of the grout material, geotechnical properties such as density, friction angle, and stiffness are increased. This technique reduces permeability while providing additional strength to existing underlying stratigraphy.

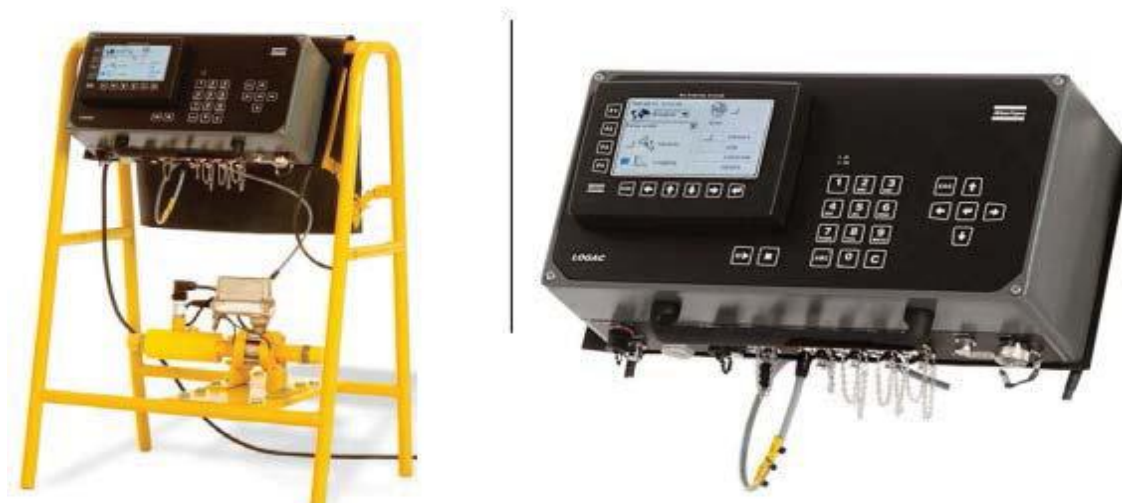
**Figure 2-6:** Typical real time monitoring and equipment and data acquisition system (Quinones-Rozo, 2010).

Monitoring Lugeon values during the installation of a grout curtain is the current state-of-the-practice for assessing grout curtain effectiveness. Lugeon values are defined as the injected volume of water in a length of time per length of rock beneath the reference elevation (Lugeon, 1933). The most common units attributed to the Lugeon value is 1 liter/minute per meter at a reference pressure of 1 MPa. Although the Lugeon value is similar to hydraulic conductivity, the Lugeon value is typically used in rock masses in which water travels through cracks in rocks, whereas hydraulic conductivity is used in conjunction with water traveling through soil pore space. Monitoring Lugeon values has many benefits. Benefits of ascertaining Lugeon values include the determination of flow characteristics provide a sound basis for the selection of an appropriate grout mix, and most importantly for quality control purposes (Weaver, K. and Bruce, D., 2007). Lugeon values are used combined with qualitative measures such as engineering judgment and rules-of-thumb (Bruce, 1982; Quinn et al., 2011; Berhane and Walraevens, 2013) to address the effectiveness and structural integrity of grout curtain walls. Lugeon values have been increasingly used as a means to assess quality control of grouting operations due to technological advancements in data acquisition systems and real time monitoring equipment. According to Houlsby (1976), quality assurance of a grout curtain with the use of Lugeon values is a key component to assessing the effectiveness of a grout curtain. A typical real time monitoring equipment and data acquisition system currently used in industry can be seen in Figure 2-6. The combination of real time monitoring equipment and data acquisition systems have allowed researchers (Sasaki and Tosaka, 2012; Sadeghiyeh et al., 2013) to monitor Lugeon values during grout curtain installation procedures. As the costs for real time monitoring systems and data acquisition systems start to decline due to competitive markets, Lugeon values are going to become even more widely used.

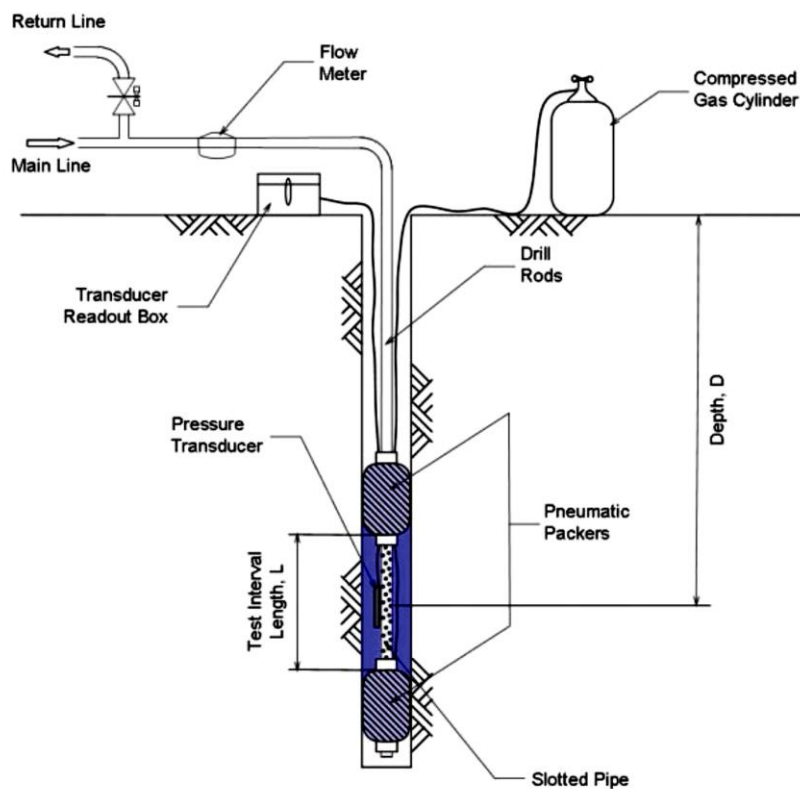
**Figure 2-7:** Schematic Lugeon test set-up (Quinones- Rozo, 2010).

During each stage, water pressure is held constant, while pumping as much water through the test interval as possible. A schematic figure illustrating a Lugeon test configuration is presented in Figure 2-7.

During each stage, flow rate and pore pressure measurements are taken. These measurements are subsequently used to calculate a Lugeon value based on an equation presented in Houlsby (1976) and Quinones-Rozo (2010). The equation presented in Houlsby (1976) and Quinones-Rozo (2010) is the standard equation that is currently being used by industry to determine Lugeon test values, which can be seen in Equation 1.

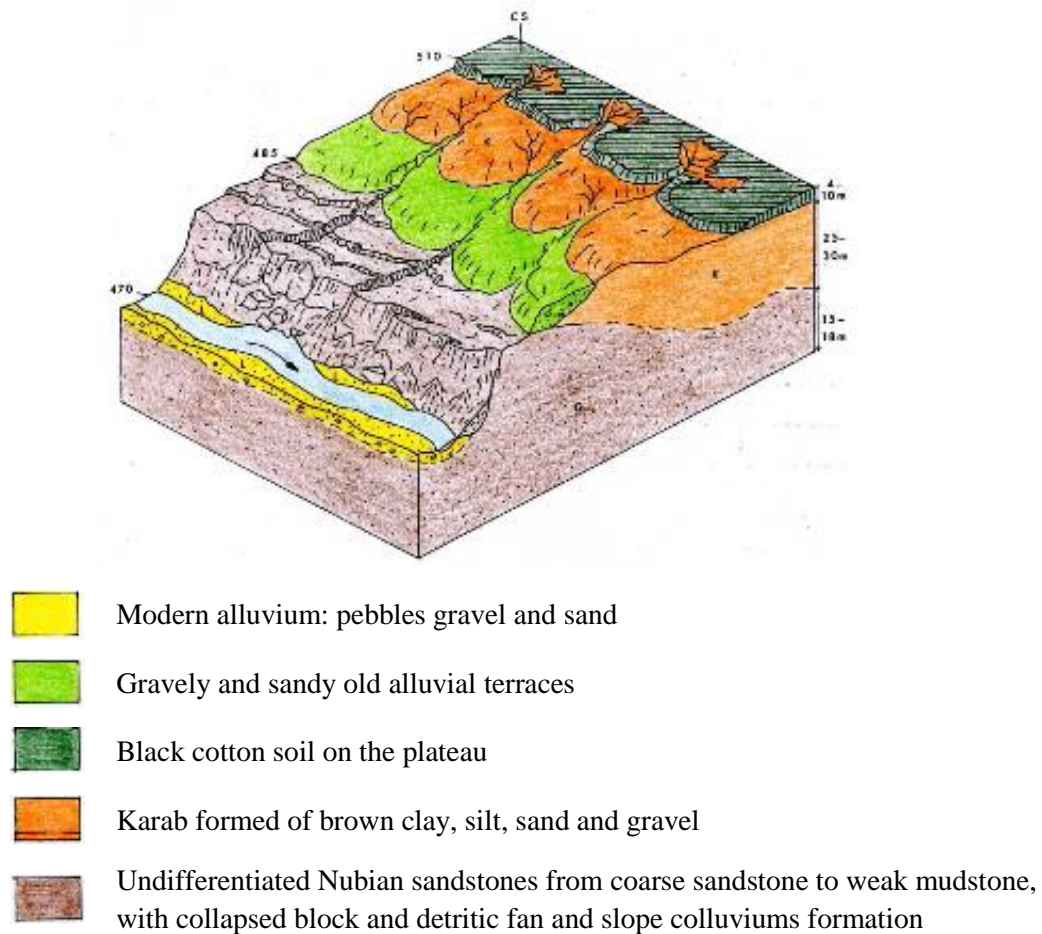
**Figure 3-1:** Different types of ground in the region and their relative position on the dam sites and ancillary from Chialvo

There is a generalized and continuous aquifer in the Nubian sandstones underlying nearly all the area. Discontinuous small aquifers can be observed in the Karab formations where the layers are below the river beds. The aquifer is fed by infiltration of river water essentially during the flood season and drained by the same river during the dry season. Figures A-2, A-3 and A-4 in Appendix (A) Show an example for geological drilling log with Lugeon test results at studies stage and part of geological section along the Dam Axis.

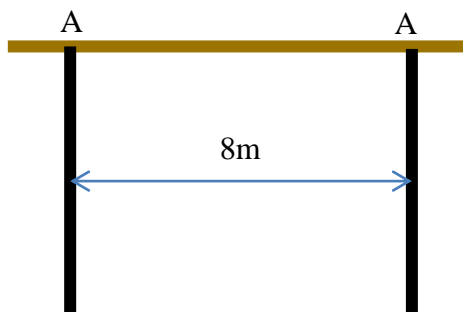
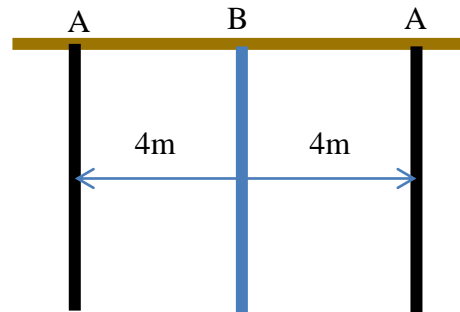
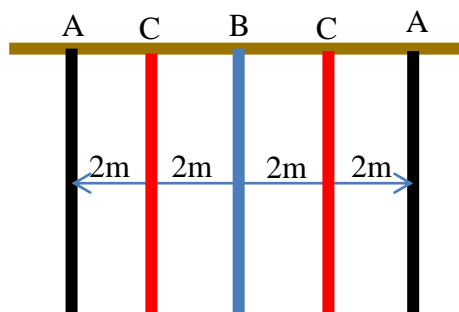
**Figure 3-2:** Slit-spacing method for grouting the holes

1 : Series A is drilled with primary spacing

2: Series B is drilled and split the secondary spacing

3: Series C is drilled and split the tertiary spacing

Grout curtain had been constructed by the slit-spacing method with all holes in the

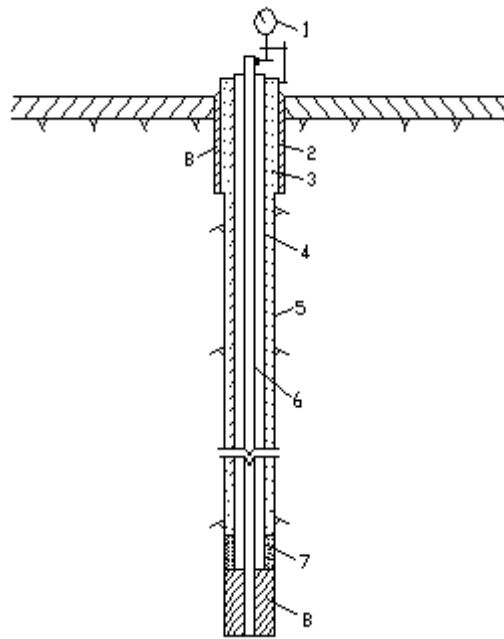
**Figure 3-3** Uplift Monitoring Device

Generally, it's considered that the installing the uplift monitoring device for every grout cap concrete block, namely, one uplifting monitoring device one concrete block. The depth of uplift monitoring hole should be no less than 15m. The Structure and installation are shown in Figure 3-3.

- 1-Dial gauge 2-Collar pipe 3-Fine sand 4-Protectiver pipe 5-Hole 6-Internal pipe  
7-Sealing material (clay) 8-cement grout

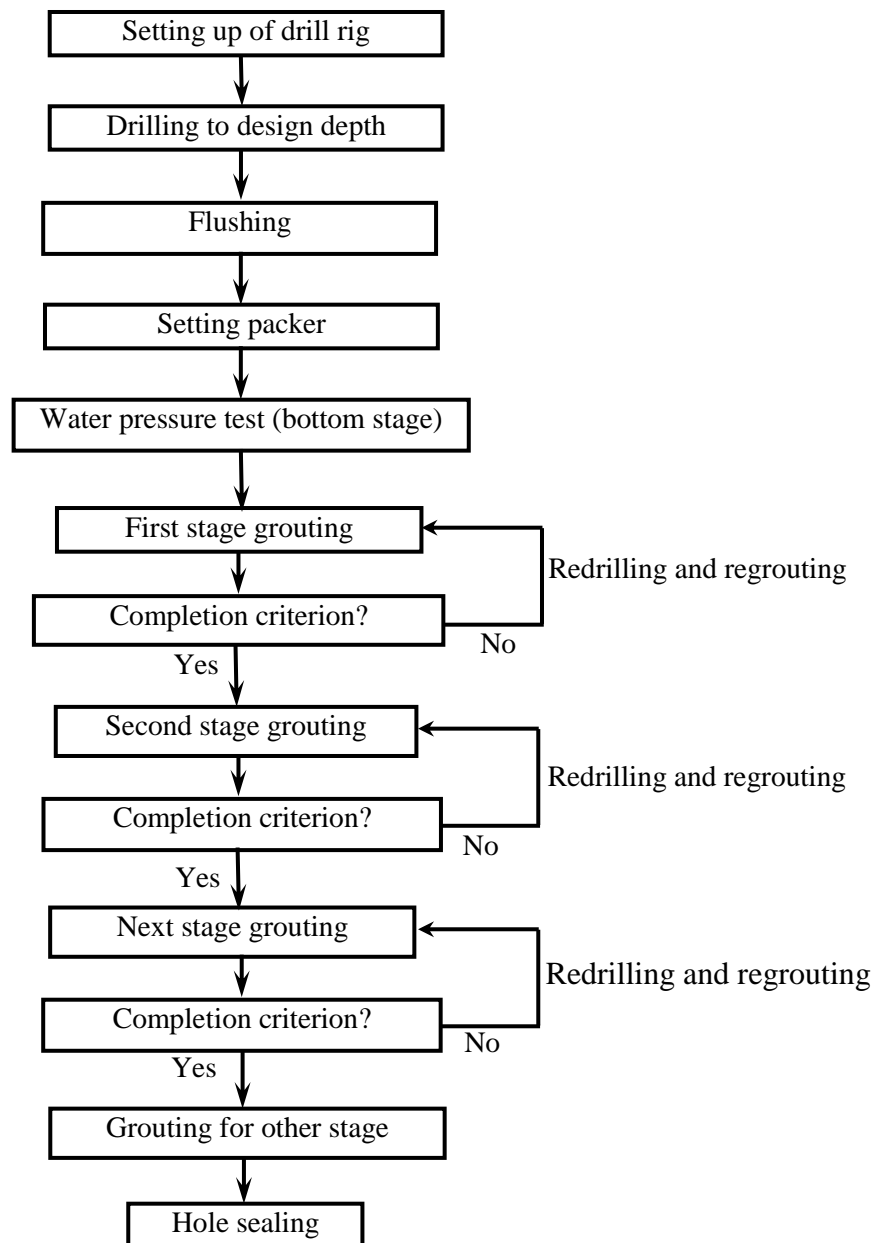
**Figure 3-4:** Ascending grouting procedure

The ascending grouting procedure and descending grouting procedure are shown as **Figures 3-4** and **3-5**.

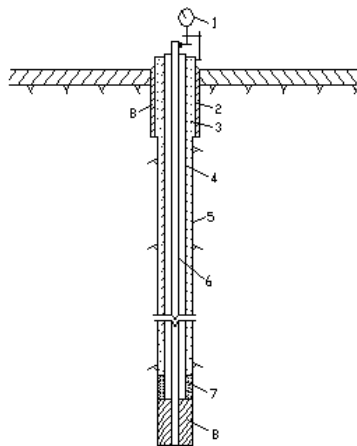
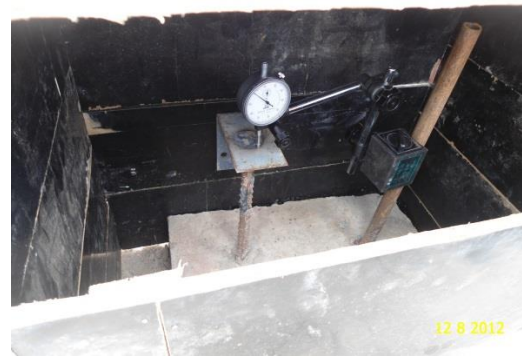
**Figure A-10 : Up-lift Monitoring Device**

1-Dial gauge, 2-Collar pipe, 3-Fine sand, 4-Protectiver pipe, 5-Borehole, 6-Internal pipe 7- Sealing material (Bentonite), 8-cement grout

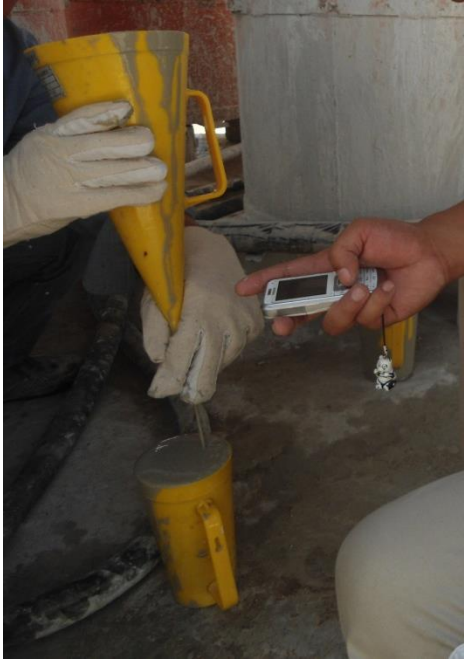
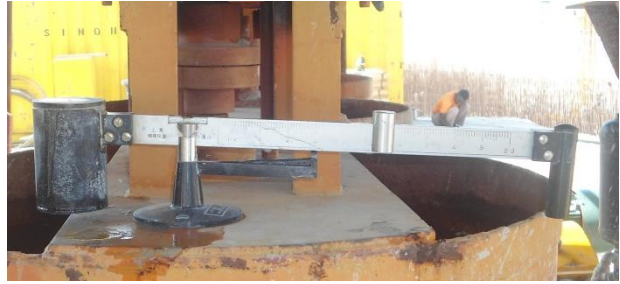
**Figure A-16 : Grout Quality Control Tests (Viscosity and Density)**

Marshal Cone test

Mud Balance test
