CHAPTER ONE

INTRODUCTION

This research investigates the strengthening of reinforced concrete structures (Columns, Beams, Foundations, slabs and RC walls) and take a local building as a case study. To achieve the target of the research, the following specific objectives are proposed:

This chapter deals with the re-analysis and assessment of local building which is subjected to failure due to bad construction and the difference between the actual design detailing and the structural section for existing building.

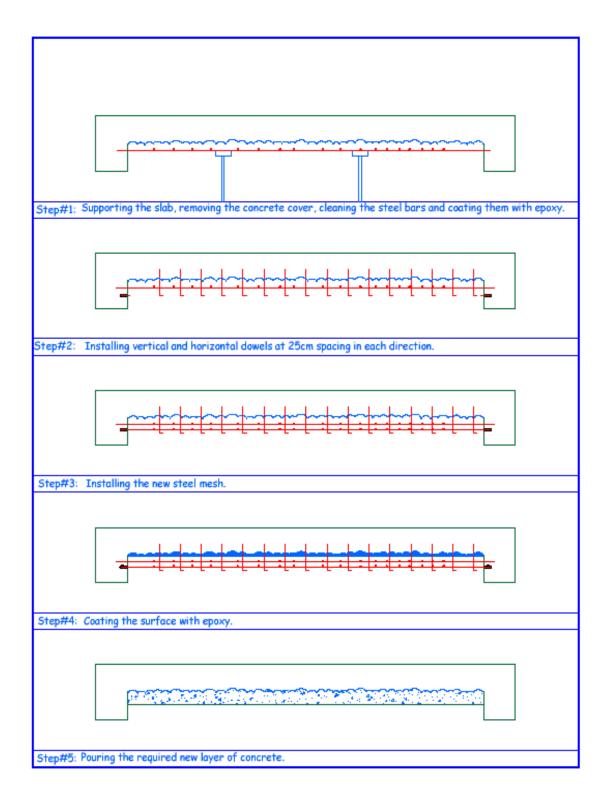
Figure (2.1): Strengthening a slab by increasing its depth from bottom

• Removing the old concrete cover.

- Cleaning the reinforcing steel bars using a wire brush or a sand compressor.
- Coating the steel bars with an epoxy material that would prevent corrosion.
- In presence of corrosion in the steel bars, a new steel mesh, designed according to the codes' requirements, must be added.
- The new reinforcing steel mesh is then installed and fastened vertically to the slab of the roof and horizontally to the surrounding beams, using steel dowels.
- Coating the concrete surface with an appropriate epoxy material that would guarantee the bond between the old and new concrete.
- Before the epoxy dries, the concrete is poured with the required thickness. Additional materials that would lower the shrinkage should be added to the concrete.

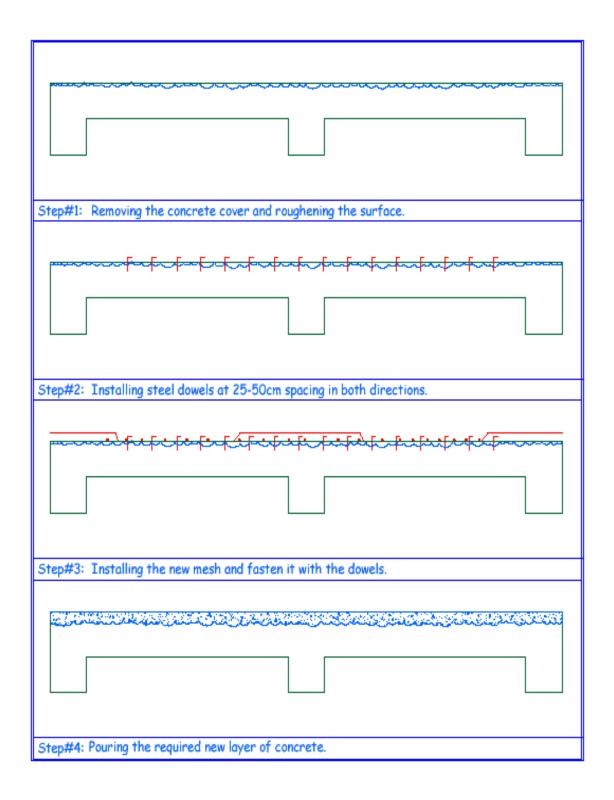
Figure (2.2): Strengthening a slab by increasing its depth from top.

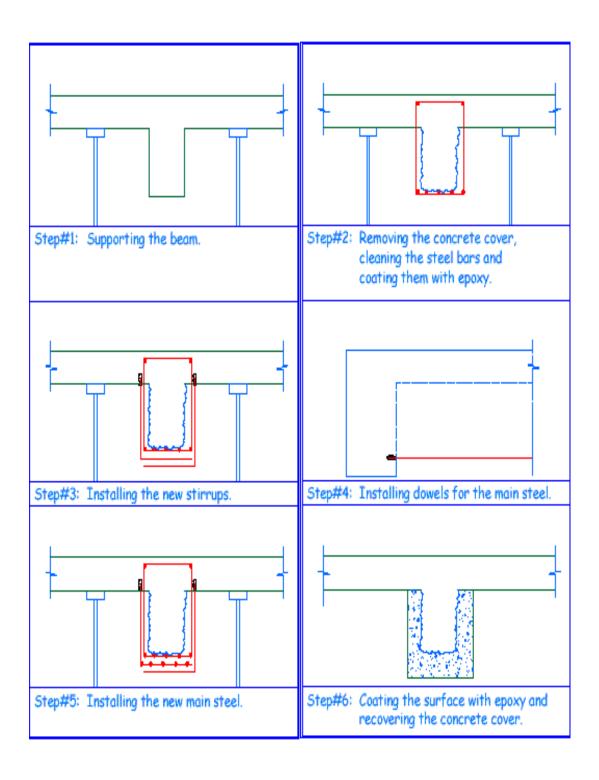
Figure (2.4): Strengthening a beam without increasing the cross sectional area.

- The concrete cover is removed for both the upper and lower steel bars.
- The steel bars are well cleaned and coated with an appropriate material that would prevent corrosion.
- Holes are made, in the whole span of the beam under the slab, as shown in Fig (2.3), 15-25cm apart, a diameter of 1.3cm and extend to the total width of the beam.

- The holes are filled with an epoxy material with low viscosity and installing steel connectors for fastening the new stirrups.
- Steel connectors are installed into the columns in order to fasten the steel bars added to the beam.
- The added stirrups are closed using steel wires and the new steel is installed into these stirrups.
- The surface is then coated with a bonding epoxy material.
- The concrete cover is poured over the new steel and the new stirrups.

The previous steps are illustrated in Fig (2.4).

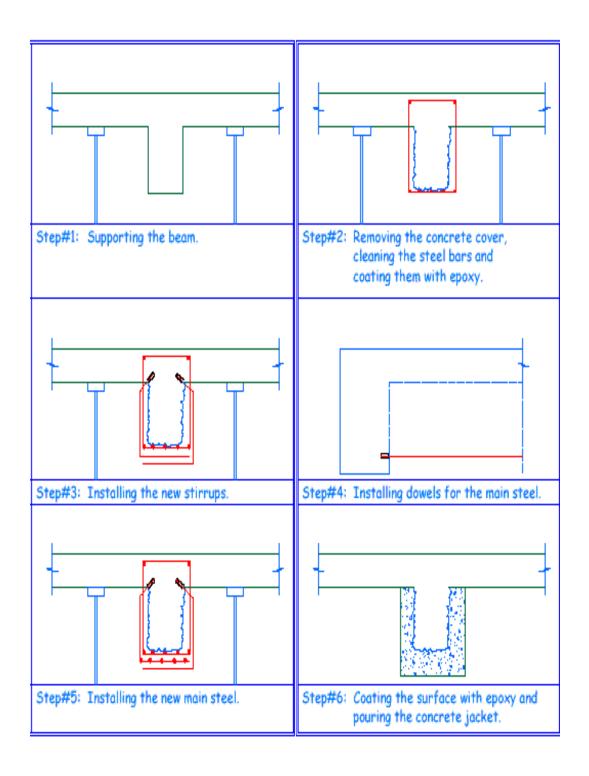
Figure (2.5): Strengthening a beam by increasing the cross sectional area and the bars.

This solution is chosen when both the steel and concrete are not able to carry the additional loads applied to the beam. In such cases the following steps should be followed as in Fig (2.5).

- Removing the concrete cover, roughing the beams surface, cleaning the reinforcement steel bars and coating them with an appropriate material that would prevent corrosion.
- Making holes in the whole span and width of the beam under the slab at 15-25cm.
- Filling the holes with cement mortar with low viscosity and installing steel connectors for fastening the new stirrups.
- Installing the steel connectors into the columns in order to fasten the steel bars added to the beam.
- Closing the added stirrups using steel wires and the new steel is installed into these stirrups.
- Coating the concrete surface with an appropriate epoxy material that would guarantee the bond between the old and new concrete, exactly before pouring the concrete.
- Pouring the concrete jacket using low shrinkage concrete.

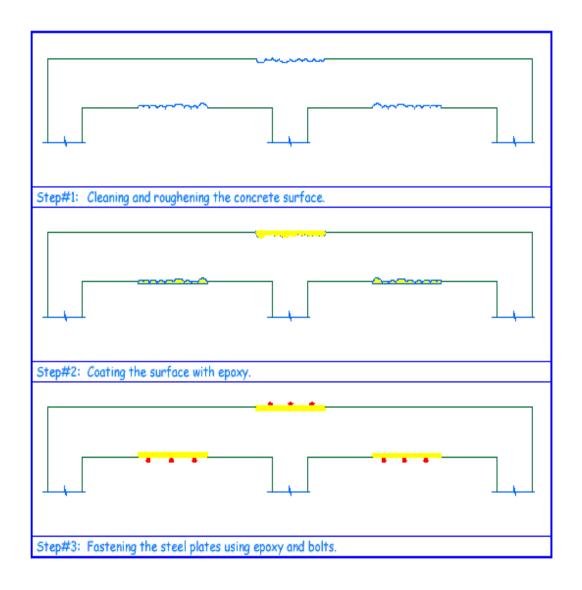
Figure (2.6): Strengthening a beam by adding steel plates.

- Roughing and cleaning the concrete surfaces where the plates will be attached.
- Coating the concrete surfaces with a bonding epoxy material.
- Making holes in the concrete surfaces and plates.
- Putting a layer of epoxy mortar on top of the plates with a 5mm thickness.
- Attaching the steel plates to the concrete using bolts.

The previous steps are illustrated in Fig (2.6) which shows steel plates attached to slab.

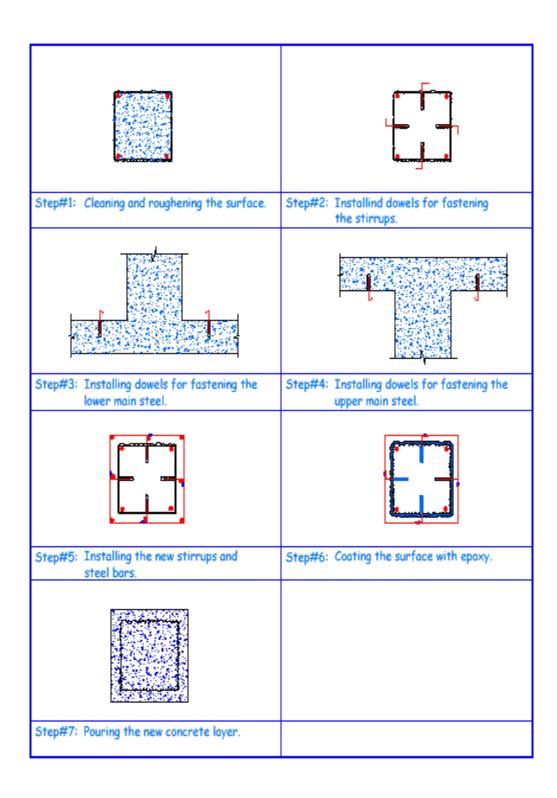
Figure (2.9): Increasing the cross sectional area of a column by RC jacketing.

- Pouring the concrete of the jacket before the epoxy material dries. The
 concrete used should be of low shrinkage and consists of small
 aggregates, sand, cement and additional materials to prevent
 shrinkage.

The previous steps are illustrated in Fig (2.9).

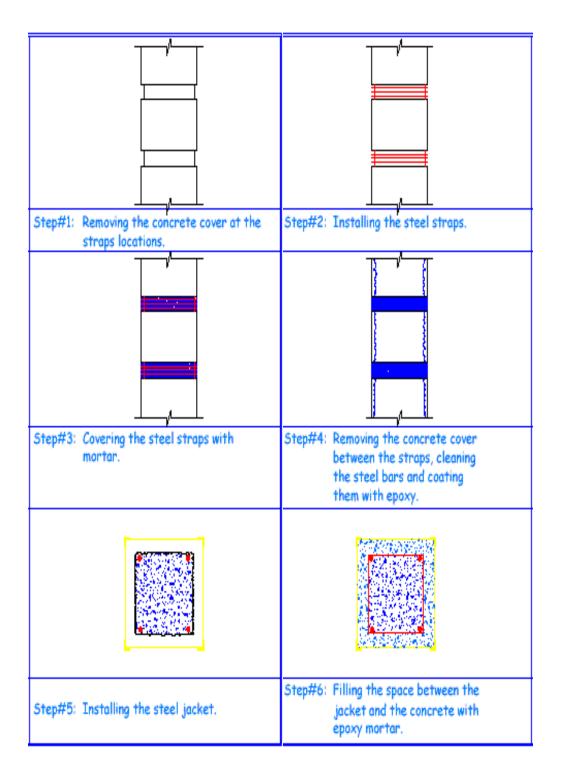
Figure (2.10): Increasing the cross sectional area of a column by steel jacketing.

This technique is implemented by the following steps as shown in Fig (2.10) (Edward.G.Nawy; 2003):

- Removing the concrete cover.
- Cleaning the reinforcement steel bars using a wire brush or a sand compressor.
- Coating the steel bars with an epoxy material that would prevent corrosion.
- Installing the steel jacket with the required size and thickness, according to the design, and making openings to pour through them the epoxy material that would guarantee the needed bond between the concrete column and the steel jacket.
- Filling the space between the concrete column and the steel jacket with an appropriate epoxy material.

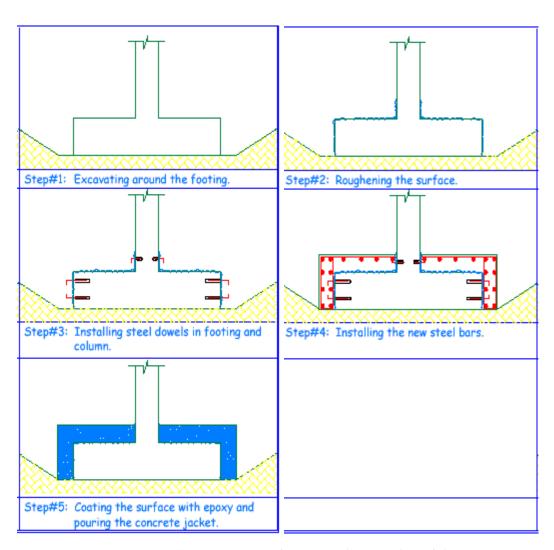
Figure (2.11): Strengthening of an isolated footing.

- Fastening the new steel bars with the dowels using steel wires. The diameter and number of steel bars should be according to the design.
- Coating the footing surface with a bonding agent in order to achieve the required bond between old and new concrete.
- Pouring the new concrete before the bonding agent dries. The new concrete should contain a non-shrinkage material.

The previous steps are illustrated in Fig (2.11).

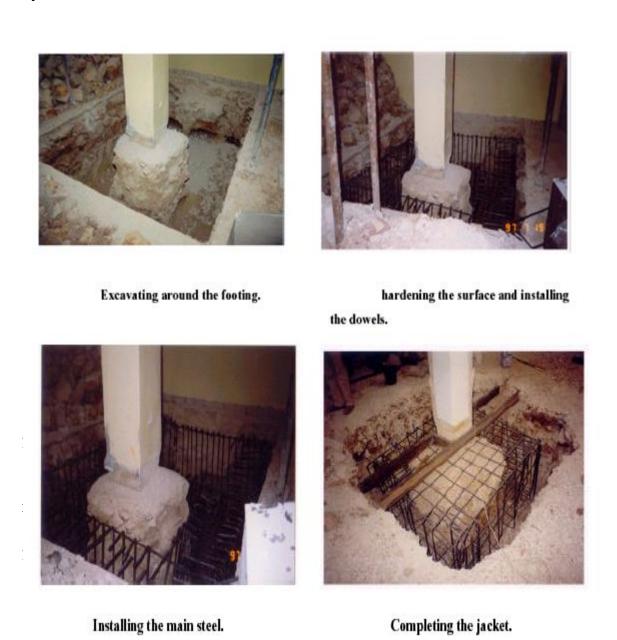
Figure (2.12): practical way of jacketing a footing by reinforced concrete.

The following *figure* (2.12) illustrate the practical way of jacketing a footing by reinforced concrete.

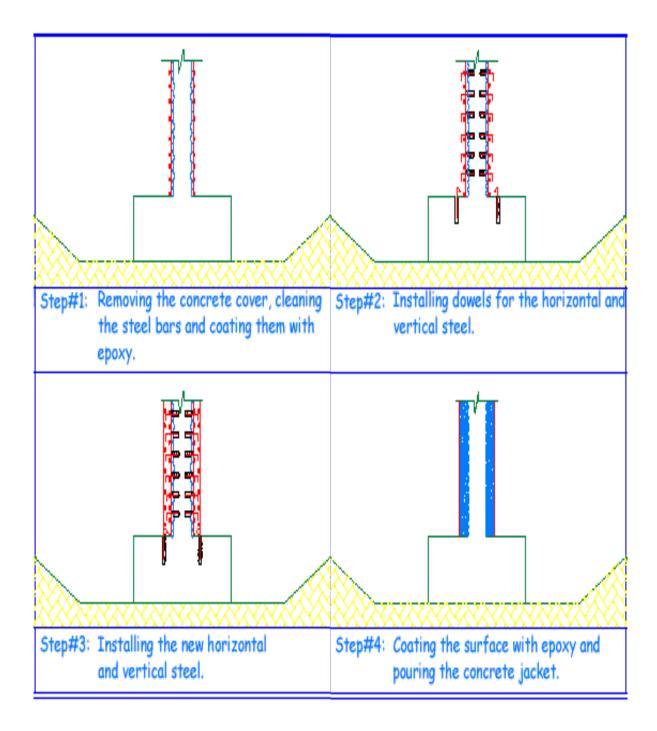
Figure (2.13): Strengthening of reinforced concrete walls

- Roughing the total area of the concrete surface.
- Installing steel connectors for the whole surface at 25-30cm spaces in both directions. The diameter of the steel connectors is determined according to the design and their depth should be 5-7 times their diameter.
- Installing steel connectors into the wall footings, with the same number and diameter of the main vertical steel bars, using an epoxy material.
- Installing the steel mesh and fasten it by steel wires to the steel connectors.
- Coating the surface of the wall with an appropriate epoxy material.
- Pouring the concrete jacket using low shrinkage concrete before drying of the epoxy material.

The previous steps are illustrated in Fig (2.13).

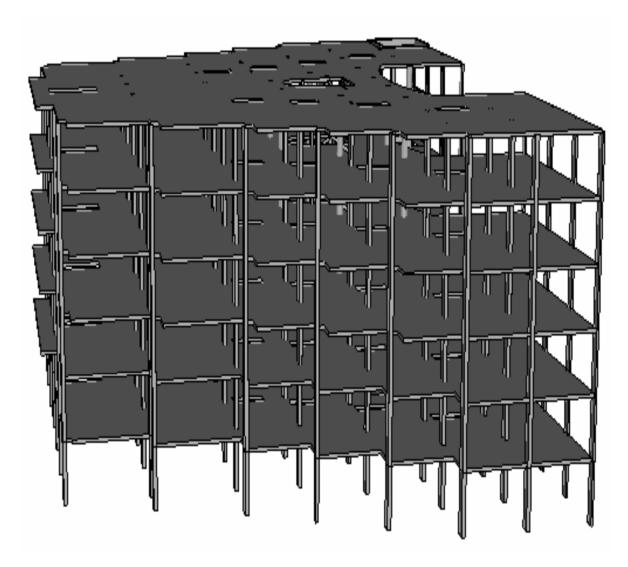
Figure 3.1: Rendered View of Model

A three dimensional finite element model of the building in question was generated for one half of the symmetrical building using Axis VM software and the drawings provided by the client (Appendix A & B). The model was used to compute the internal forces in the building structural members due to the different load combinations.

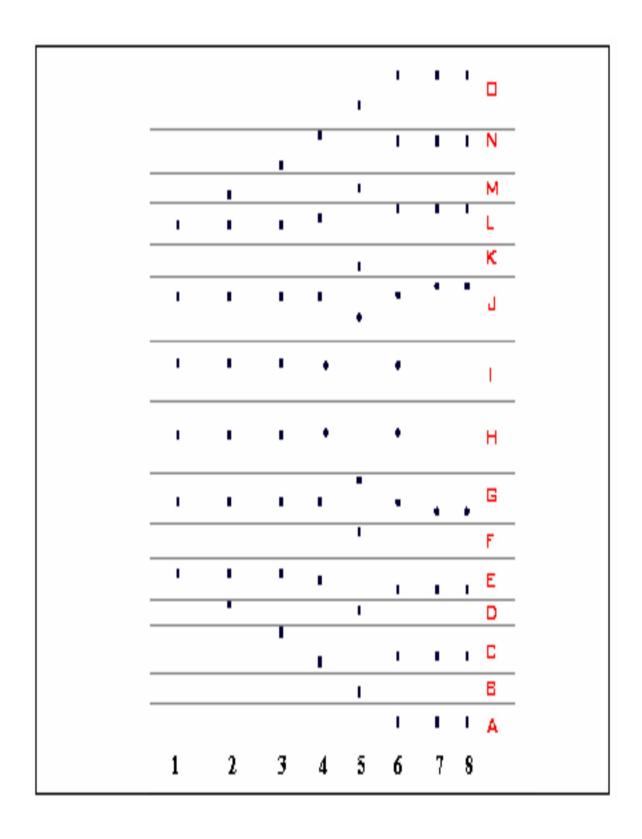
Figure 3.2: Footing designation

The footings of the building are a mix of type F1 (2.20m×2.20m×0.5m) and F2 (2.40m×2.40m×0.5m). The capacity of the footings was checked for adequacy to carry the obtained footing loads under load combination 2 (Service Load). The results show that 30 of the 60 footing in the analyzed part of the building were inadequately sized by more than 30% and some of footing (14) are severally undersized to the extent that the pressure they apply on the soil exceed twice the allowable bearing capacity.

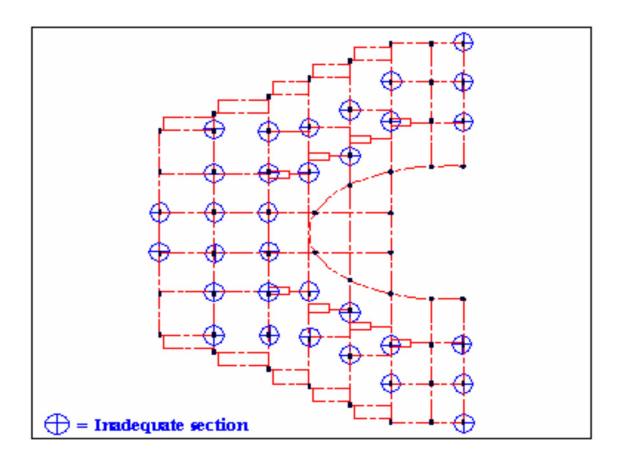
Figure 3.3: Inadequately sized short columns

The internal forces for each of the columns of the building are shown in table 3.5. These forces are presented using the designation shown in figure 3.3.

All of the existing columns of the building are a mix of type C1 (0.25m×0.6m) for the internal columns, type C2 (0.3m×0.6m) for external column and C3(round 0.5mm). The capacity of columns was checked for adequacy to carry the obtained column loads under load combination 1 (Ultimate Load). This check was conducted by using spreadsheets. The spreadsheet results show that Columns number A8, C6, C8, D5, E2, E3, E4, E6, E8, F5, G2, G3, G4, H1, H2, H3, I1, I2, I3, J2, J3, J4, K5, L2, L3, L4, L6, L8, M5, N6, N8 and O8 were inadequately sized at the short columns level. A section 900mm×550mm with 4Ø20mm and 8Ø12mm instead of the used 600mm×250mm with 8 Ø 20mm should have been adopted.

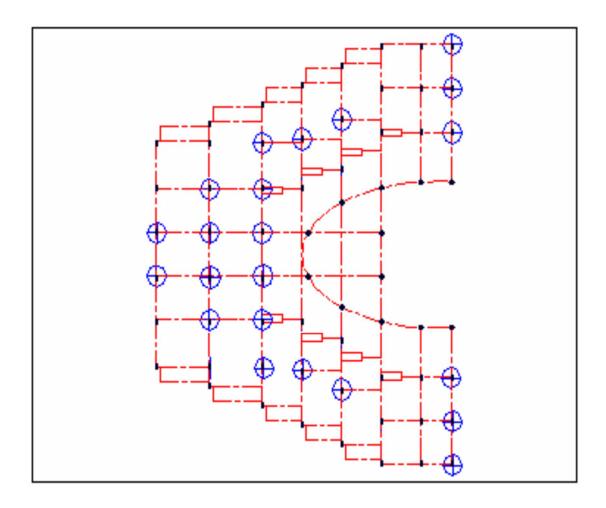
Figure 3.4: Inadequately sized ground floor columns

At the ground floor level columns number D5, E3,E4,G2, G3, H1, H2, H3, I1, I2, I3, J2, J3, L3, L4, L5, M5, A8, C8, E8, L8, N8 and O8 were inadequately sized. A section 900mm×550mm with 4Ø20mm and 8Ø12mm instead of the adopted 600×mm250mm with 8 Ø 20mm should have been used.

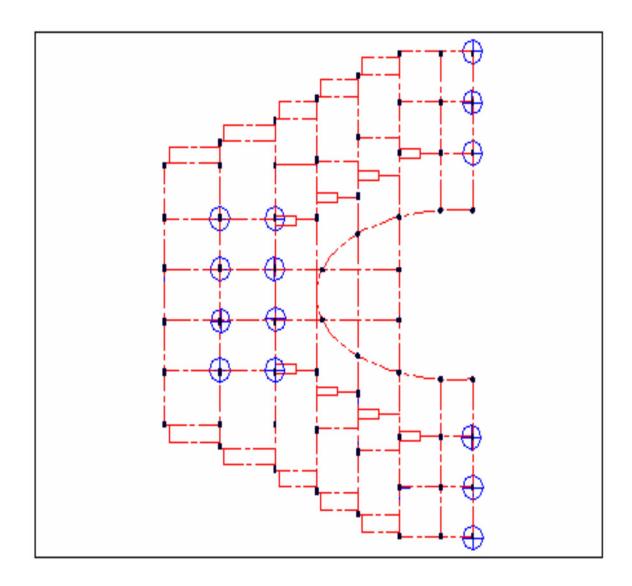
Figure 3.5: Inadequately first floor columns sized

At the first floor columns level columns number G2, G3, H2, H3, I2, I3, J2, J3, A8, C8, E8, L8, N8 AND O8 were inadequately sized. A section

$600 \text{mm} \times 300 \text{mm}$ with $4\emptyset 20 \text{mm}$ and $8\emptyset 12 \text{mm}$ instead of the used 600×250 with $8 \emptyset 20 \text{mm}$ should have been adopted .

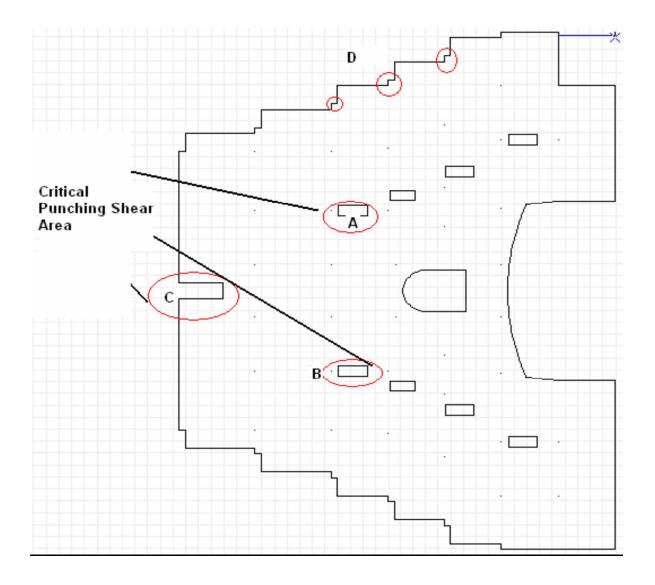
Figure 4.1: Critical Punching shear areas

Punching Shear check is taken in four critical areas as shown in the figure 4.1 below which include:

- Internal perimeter A&B
- Edge D
- Edge C

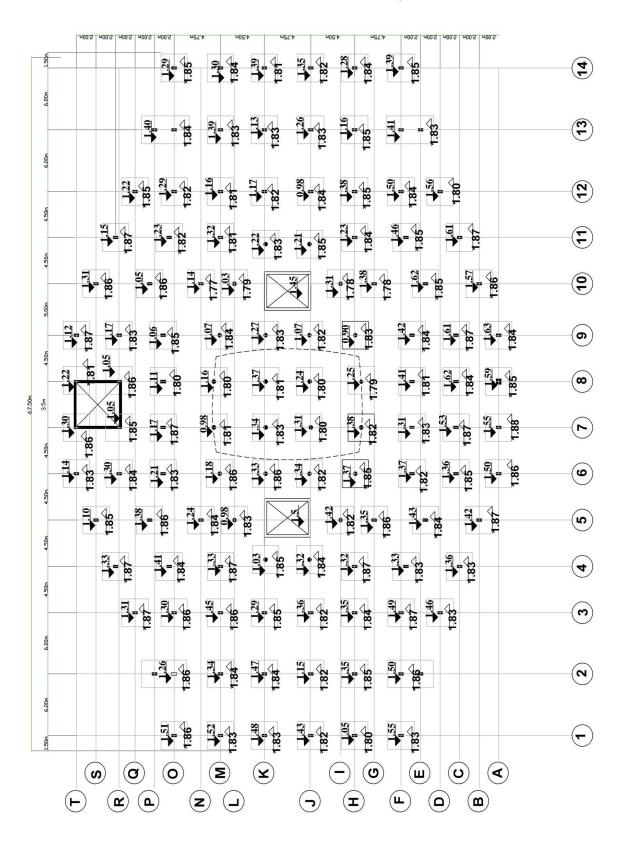
Appendix (C): Internal Columns Strengthening Details.

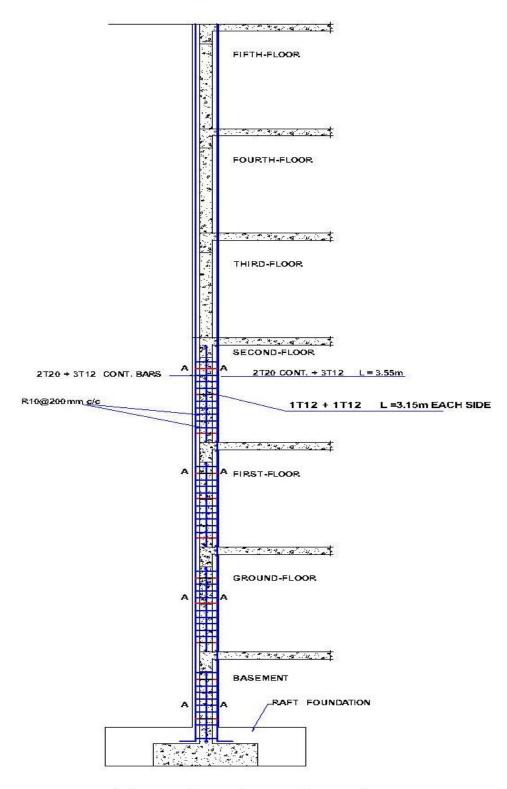
Appendix (E): External Columns Strengthening Details.

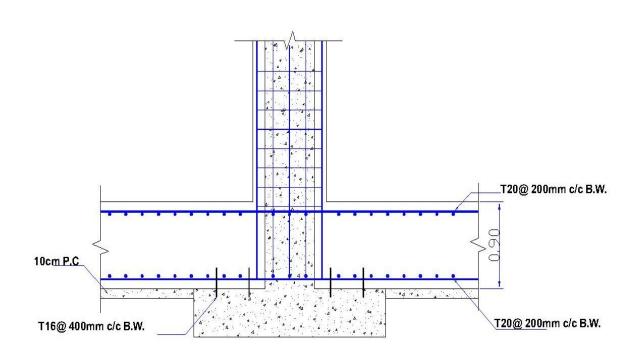
Appendix (G1): Raft foundation details.

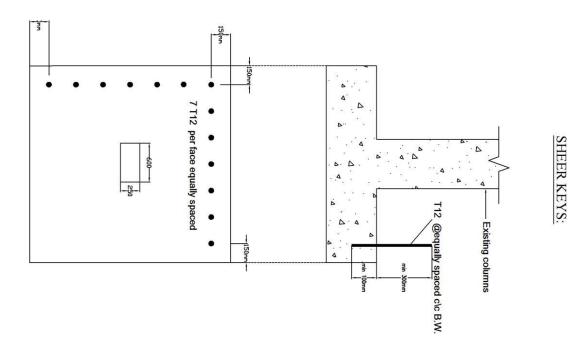
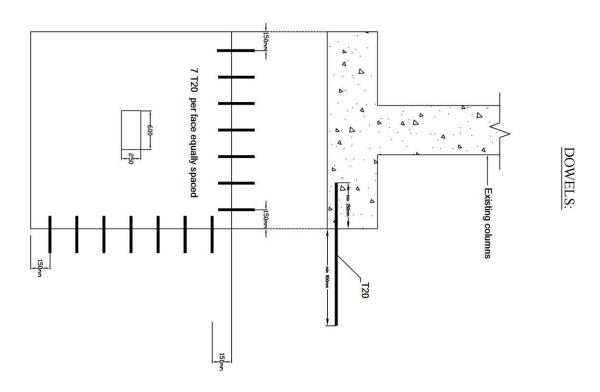
Appendix (H): Shear keys in old foundations.

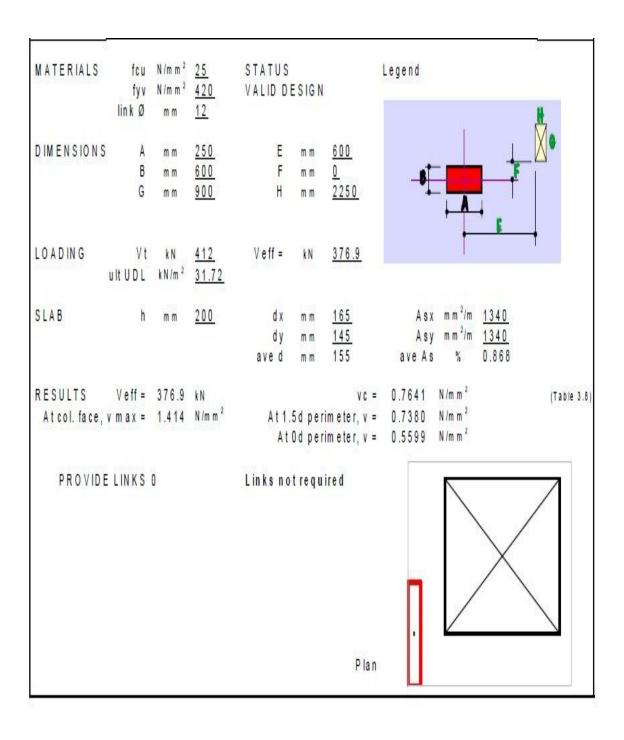
Appendix (I): Punching Shear Check for Critical Areas A and B:

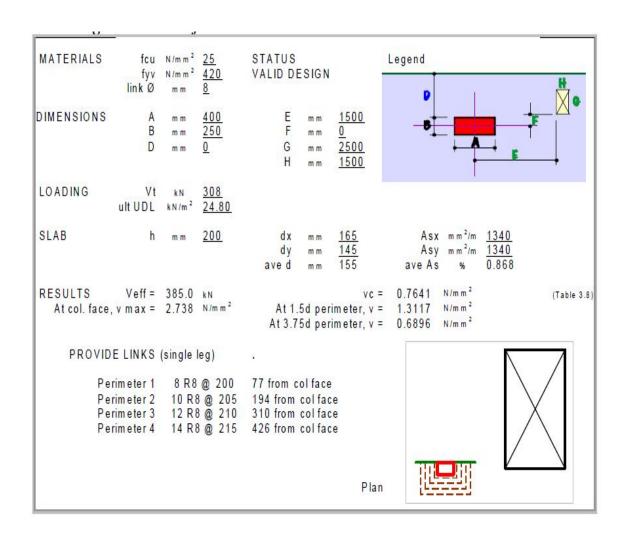
Appendix (j): Punching shear check for critical area C:

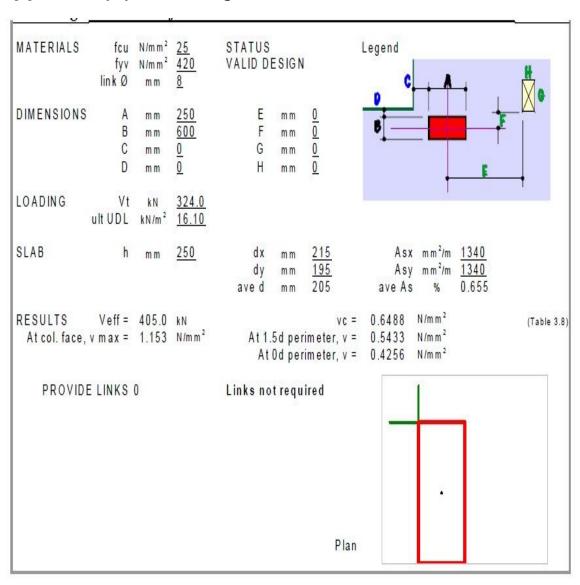
Appendix (K): Punching shear check for critical area D

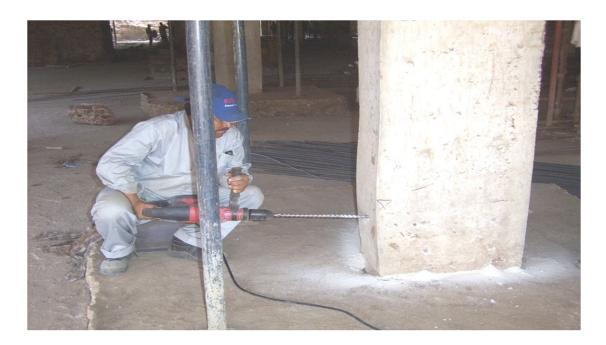
Appendix (M): Described the Punching of columns in preparation for adding shear connectors for the concrete jacket

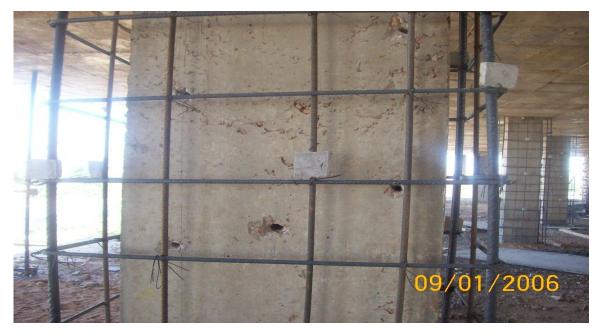
Appendix (N): Filling the holes with an appropriate epoxy material then inserting the shear connectors into the holes.

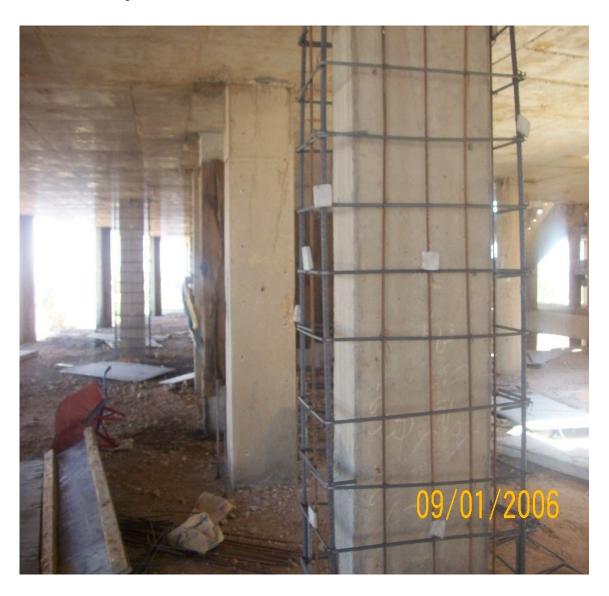
Appendix (O): Describe how to strengthen the column by adding the design reinforcement steel jacket and stirrups, before casting the concrete jacket.

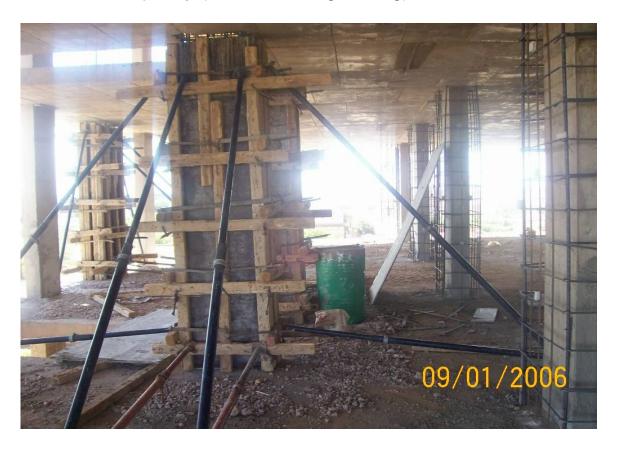
Appendix (P): Shown the column jacket shuttering to increase the section capacity (Column strengthening).

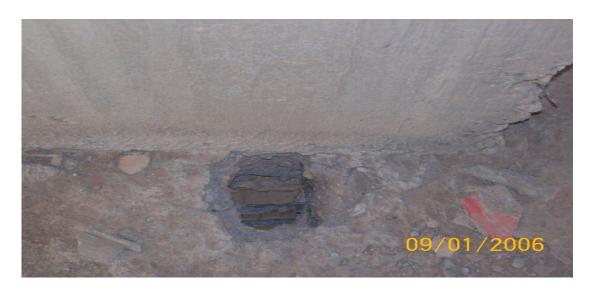
Appendix (Q): Drilling hole on slab to fill the grout cement on the top of the column.

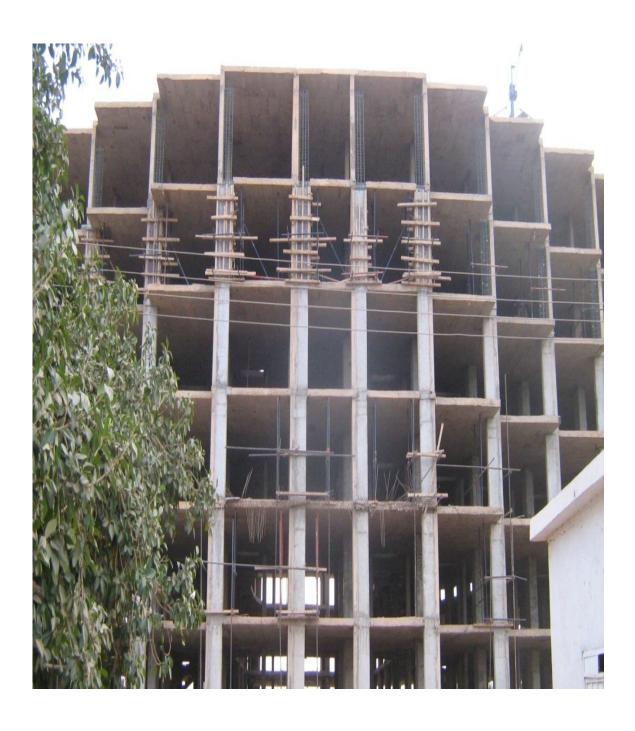
Appendix (R): Showing the strengthening of the external columns.

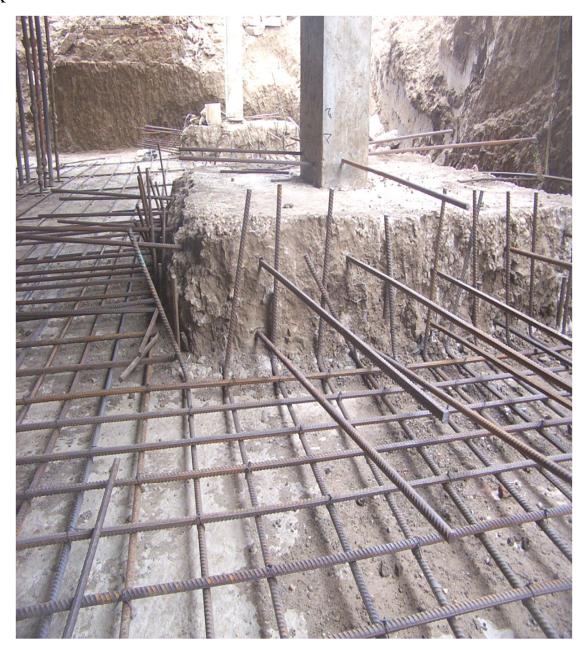
Appendix (W): Describe the foundations convert from isolated to Raft footing, and appears that the reinforcing bars fixed in the old foundation as a shear connectors with Epoxy material.

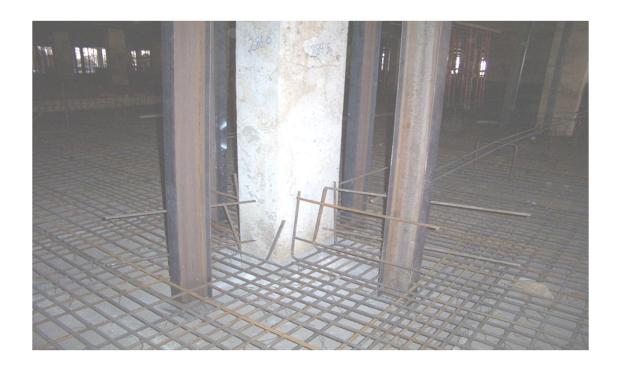
Appendix (X): Describe how to link the steel reinforcement between the Raft foundation and columns.

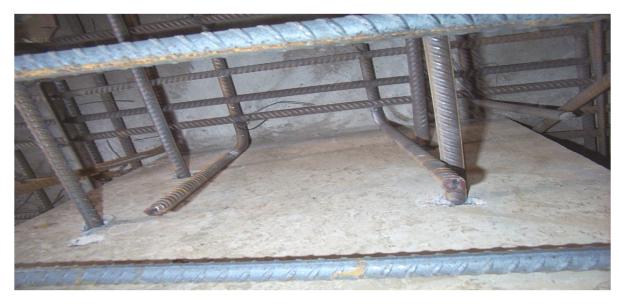
Appendix (Y): Filling the holes with epoxy material then inserting the shear connectors into the holes to connect (fixed) the Raft foundation with columns.
