Appendix (2) ultrasound images for normal eye:

Appendix (3) ultrasound images from the sample of the study

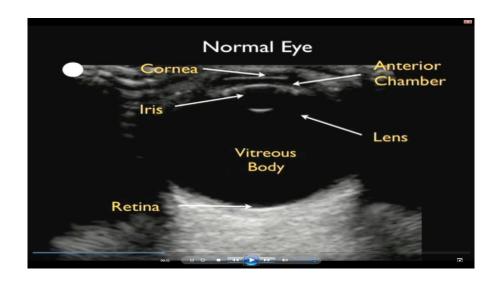
Image (1) Axial scan(A,B) shows normal findings of the eye image

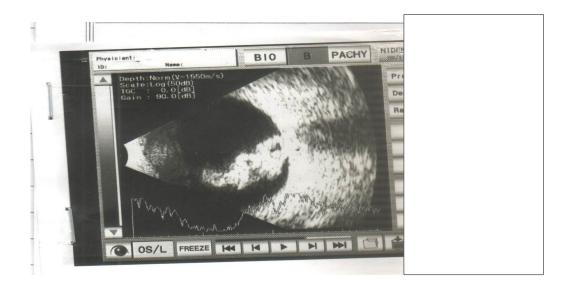
A.B axial scan image of an eye for 39 year old female shows there is a duble membrane inserting into the optic disc with a closed configuration suggestive of long standing retinal detachment. A scan shows dense cataract. High spikes.

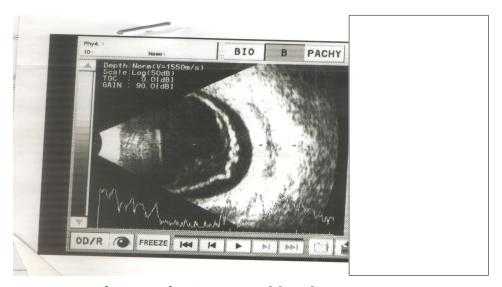
A.B axial scan image of an eye for 32 years old male, shows total retinal and vitreous detachment with dense cataract.

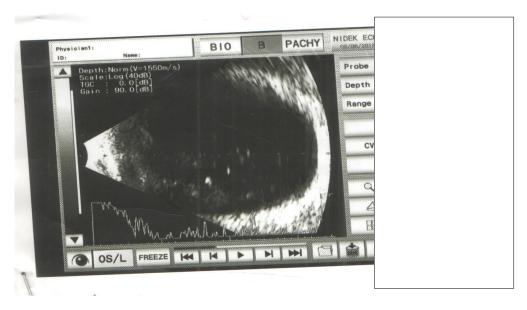
A.B axial scan image of an eye for 38 year old male shows dens cataract with staphyloma (highly myobbia). Vitreous changes seen.

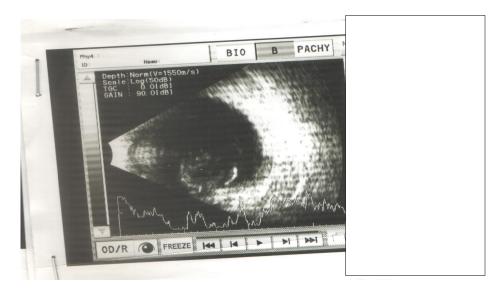
A.B axial scan image of an eye for 23 year old male shows dislocated lens due to trauma appears hyperechogenic circular mass.

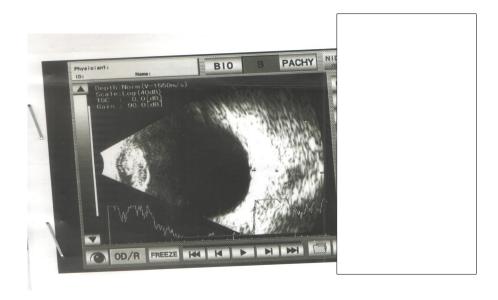
A.B axial scan image of an eye for 11 years male shows hyperechogenic or dense cataract, a scan shows high spikes.
