Appraisal of Existing River Protections in Kassala Town

Adam Khalifa Mohammed Khalifa¹, Abbas Abdalla Ebrahim², Elsadig Elhadi Elhassan³

College of Water and Environmental Engineering, Sudan University of Science and Technology (SUST)¹
School of Civil Engineering, Sudan University of Science and Technology (SUST)³

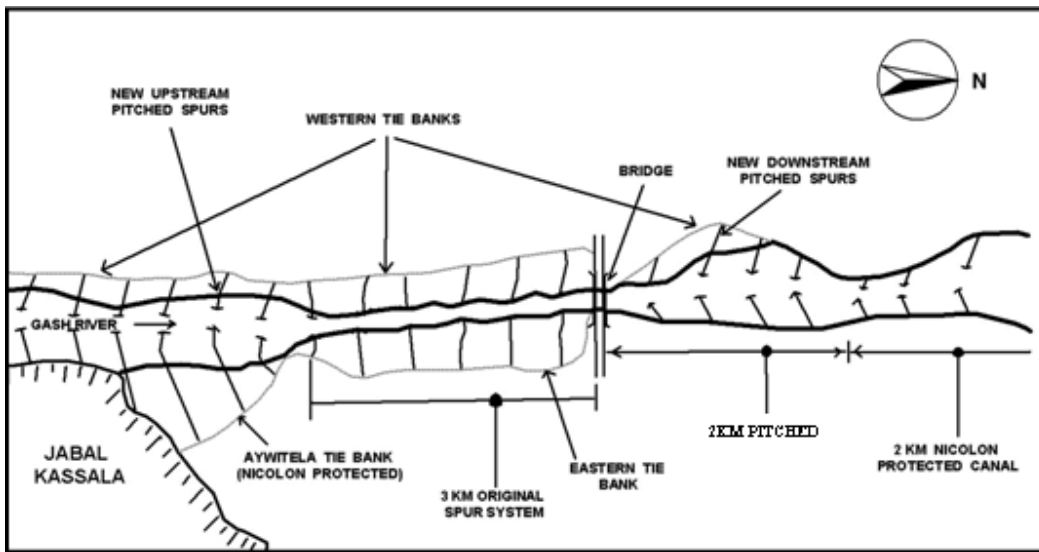
Figure 6: Existing protection works near Kassala town

The existing hydraulic structures upstream and downstream Kassala Town in both the West and East banks of the Gash River are examined. This examination is to fulfill the objective which is to assess their effects on Kassala Town and its neighboring areas. The Gash River approaches Kassala Town and passes through the main parts of the reach system under study. The reach covered by the main parts of the system is shown in Figure 6. It consists of nine categories of protection and training structures.

These are three Kilometers Original Spur System. Two Kilometers Pitched Bank. Two Kilometers Nicolon Covered Bank. New Upstream Pitched Spurs. The Bridges. Eastern Tie Bank. Western Tie Bank. Aywitella Tie Bank. New Downstream Pitched Spurs. There are also the two reaches which are: The reach between the ends of the new downstream

- system as shown in Figure 6 are the seven pairs of spurs implemented during the period from 1931 to 1936, which were with cross section shown in Figure 7, spaced 500 meters apart with a similar length of their shanks, bounding a U shaped area between their

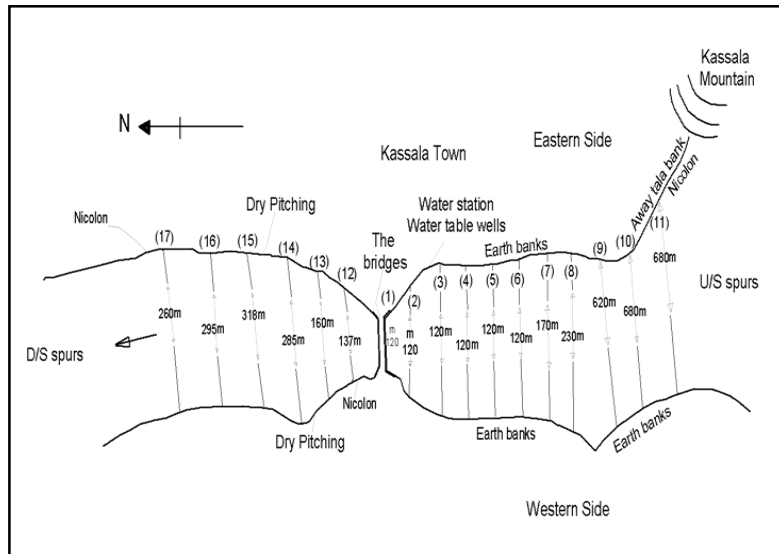
Figure 8: The variable lengths of the shanks and distance between spurs

- The total number of spurs upstream the old bridge were eleven in 2005. The new upstream pitched spurs were four pairs. The lengths of the shanks of these spurs were variable, and the horizontal distance between their heads are also different as shown in Figure 8. After 2005 the spurs and dyke system was further extended.
