SHORT COMMUNICATION UTILIZATION OF HOLOGRAPHY LASER TECHNIQUE FOR ARC- WELDING FAULTS DETECTION

Plates of mild steel, welded by arc-welding, had been tested using laser holography technique for inspecting the welding defects like: cracks, porosity and inclusions in these plates.

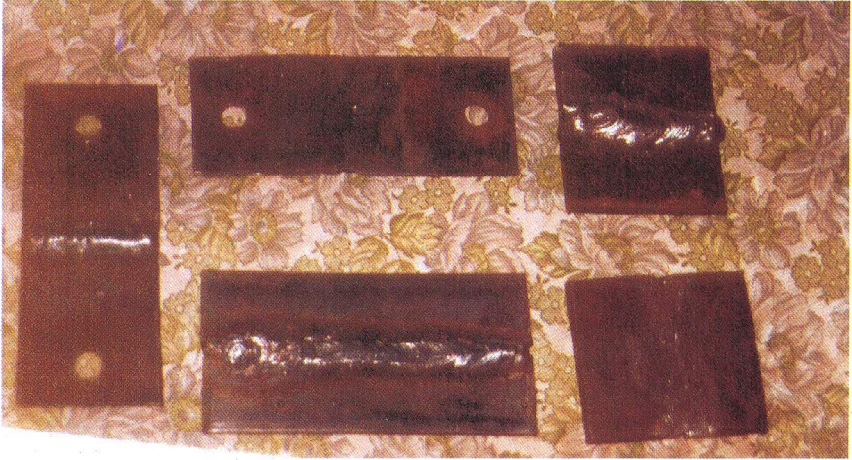
Mild steel plates 5x2.5x0.5cm, 5x4x0.2cm and 10x2x0.2cm have been jointed, with arc-welding technique, using mild steel, 10 and 12, electrode. Each pair jointed together as a butt joint. The welding joints are performed so as to have defects in the joint region, sometimes the current has been increased or decreased much more or less than it should be, and sometime the electrode is scratched, and sometimes the welding is quenched in a water, and others a second pass is used without removing the slag from the first pass, and always the welding area is not pre-cleaned^[6].

Fig. (2): Welding joints samples

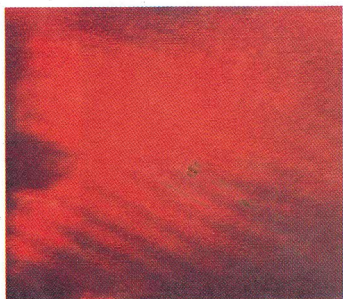
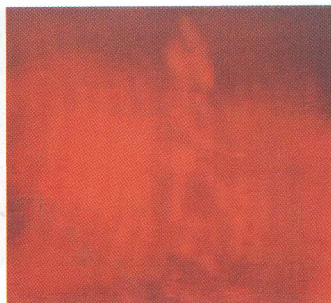
Fig. (6): Double exposure hologram of two different arc-welding joints (plate 5x5x0.5cm), 2seconds exposure time

For the known surface defects, cracks, the joint was tested and fringes curvature and discontinuity were appeared at the cracks regions as shown in (Fig. 6a) and (Fig. 6b), respectively. In (Fig. 7a), internal flaws are detected at the fringes anomalies, noncontinuity.

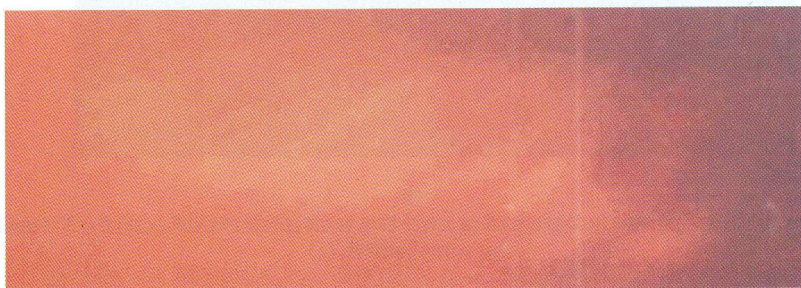
Fig. (7): (a) Double exposure hologram of arc-welding joint (plate 10x5x0.2cm) (b) X-rays image of the same joint in (a)

The same defects has been detected by the x-rays test as shown in (Fig.7b).

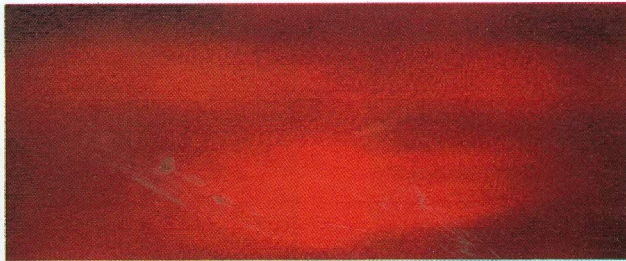
Fig. (8): (a) Double exposure hologram of arc-welding joint (plate 10x5x0.2cm) (b) X-rays image of the same joint in (a)

In (Fig.8a), half of coincident circular fringes has been obtained due to the porosity defects inside the welding joint.

Also the x-rays test showed a porous area at the welding joint, as shown in (Fig.8b).
