Sudan University of Science and Technology

Biomedical Engineering Department

Submitted in partial fulfillment of The Requirement of M.Sc Degree

Review of CT and MRI Maintenance

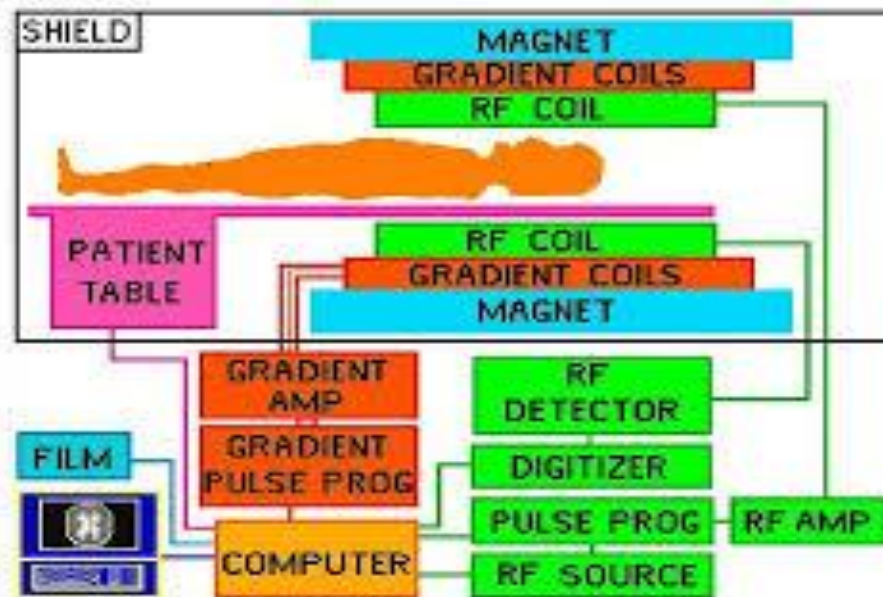
Figure (2.1): MRI composition

The system consists of several subsystems shown in figure (2.1) That together full the task of making MRI scans .The main subsystems that are used in the scanner are the magnet, patient Support System with posterior coil, gradient system (amplifier with Gradient coil), RF system (RF amplifier, RF transmit coil, RF receive coil, and pre-amplifier): and magnet with Cry cooler and chiller.

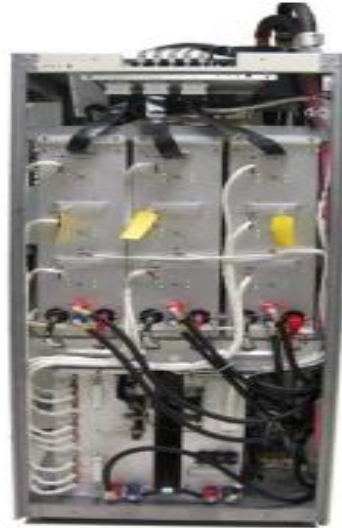
Figure (2.2): Gradient amplifier

The purpose of the Gradient amplifier (GA) [depicted in Figure (2.2)], is to produce an electrical current for the Gradient coil (GC) to produce three

orthogonal magnetic field gradients within the powerful main magnetic field of the scanner s [4].

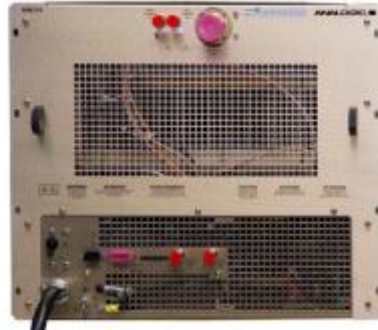
Figure (2.3): RF Amplifier

The pre-amplifier of the system shown in figure (2.3) is used to amplify MRI signal received by receive coil.

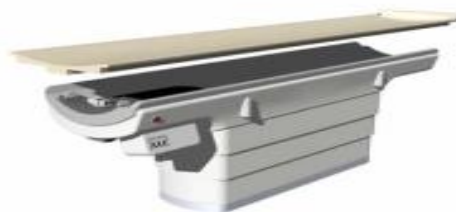
Figure (2.4): Patient Support System

The Patient Support System (PSS), despite in Figure (2.4), is used to support the patient and position the patient inside the bore. The system consists of three main parts, the table support (pedestal), which supplies the vertical movement, the carrier, which supplies the horizontal movement and the tabletop on which the patient is placed and which is removable from the carrier. To control both the movement of the pedestal and the carrier the PSS is equipped with a user interface. The pedestal is capable of moving in a vertical direction by a motor and the tabletop that is placed on top of the carrier is capable of moving in a horizontal direction by a motor [5].

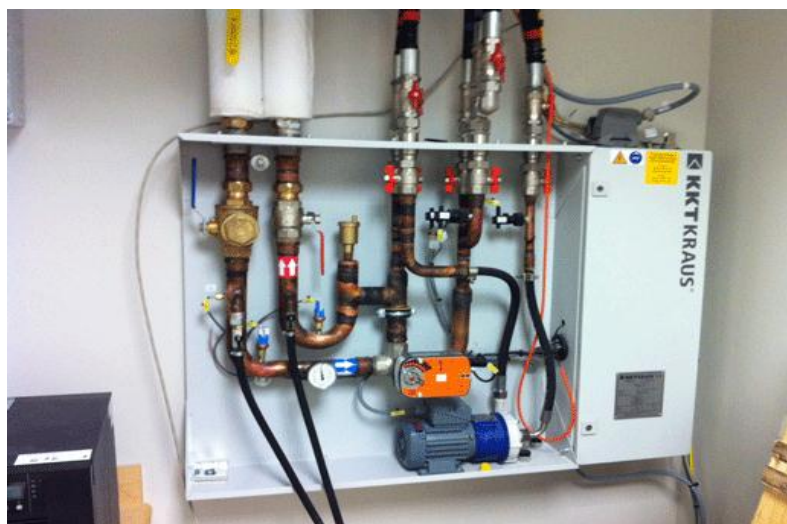
Figure (2.6); chiller

The another very important issue is a chiller .Chiller shown in figure (2.6) is a refrigeration unit That supplies cold water to cool MRI components .it is very essential for superconducting magnets. To reduce the boil-off of Helium and/or Nitrogen depending on the system configuration chillers are used to cool shield coolers, coils and sometimes the air conditioning [6].

Chiller failed due to reduce level of helium, cold head failure, slow flow of water, compressor failure, dust, defected components, contamination. The proposed solution is to provide back up of chiller, filling helium, replace cold head with another one, apply preventive maintenance, replace compressor, applying Ideal environment of chiller, consequently.

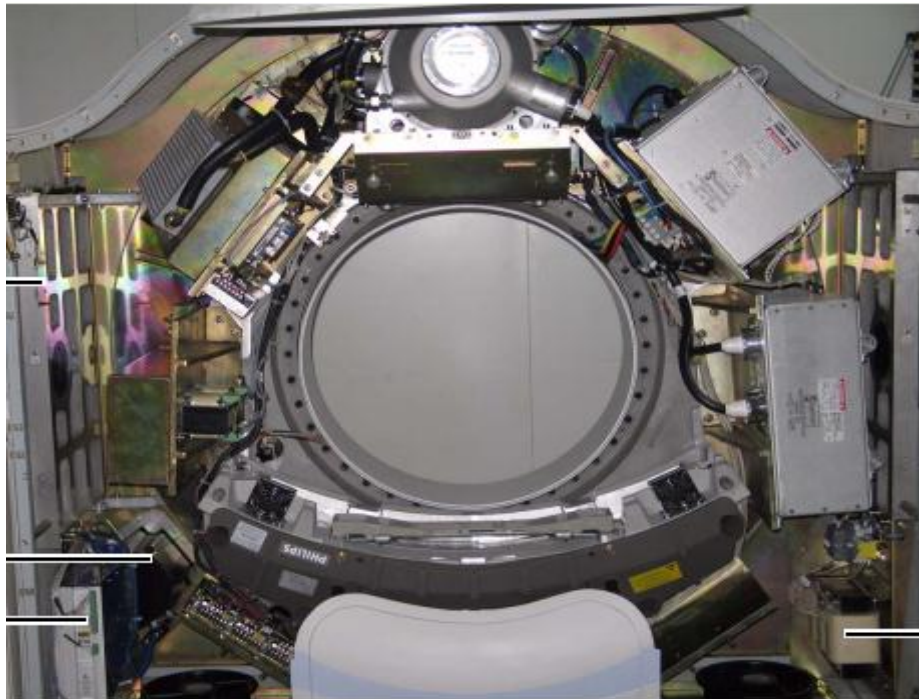
Figure (2.11): gantry

The scanner is composed of the gantry and the patient couch. The scanner shown in figure (2.11) uses a continuous X-ray beam to scan the region to be examined. Transmitted X-rays are detected and converted into electrical signals by the area detector. The gantry includes the main body and its support mechanism. The X-ray tube and the area detector are mounted facing each other on either side of the gantry aperture, and the X-ray tube and detectors rotate continuously around the aperture of the gantry. A slip ring is employed to transmit power between the gantry and the rotating X-ray high voltage generator assembly. The X-ray high-voltage generator is built into the gantry, and the system employs a high-frequency inverter for generating and stabilizing the

high voltage supplied to the X-ray tube. The generator includes electronic circuits for controlling the speed of the rotating anode in the X-ray tube [11].

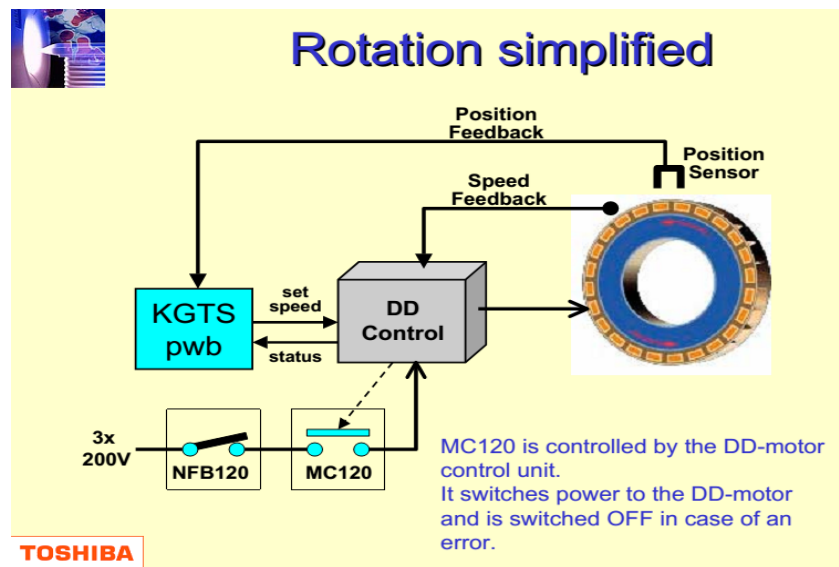
Figure (2.12): rotation of gantry.

Computed tomography (CT) gantry rotation shown in figure time (2.12) is one factor influencing image quality. Until now, there has been no report investigating the influence of gantry rotation time on chest CT image quality. Faster CT gantry rotation reduces scan time and motion artifacts. However, accelerating rotation time increases image noise and streak artifacts. Therefore, a slower CT gantry rotation speed is still recommended for higher image quality in some cases.

Moreover the main causes of faults in Gantry rotation is come from Servo Motor defect, tiltation Pump (motor) failure or due to un balance base (Vibration) .The proposed solution is to replace the defected motor or check rotation balance (Check rotation balance when changing tube or other large parts. Check the force needed to get the system moving at 0° , 90° , 180° and 270° with a push/pull gauge (limit = differences within 1 kg).

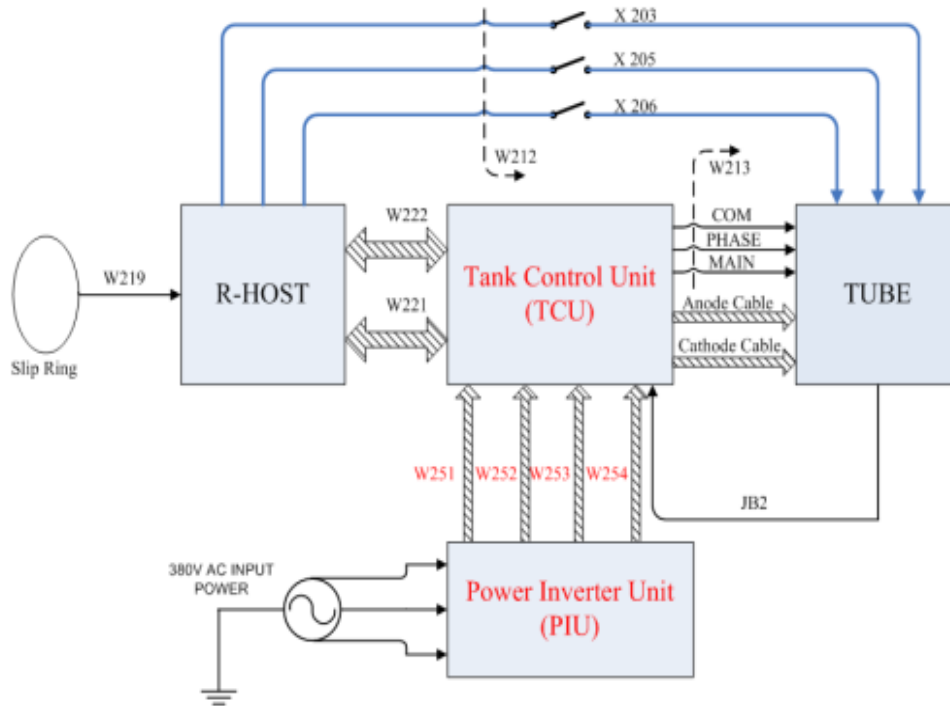
Figure(2.14): Fironia-50 system Connections.

The HV generator shown in figure (2.14) contains two parts: PIU (Power Inverter Unit) and TCU (Tank Control Unit). The PIU consists with Power Control Board, Inverter Drive Board, IGBT module, Resonant circuit and Cooling Unit.

The TCU include System Control Board, filament board, Anode Control Board. Grid Module is in Tank oil box [12].

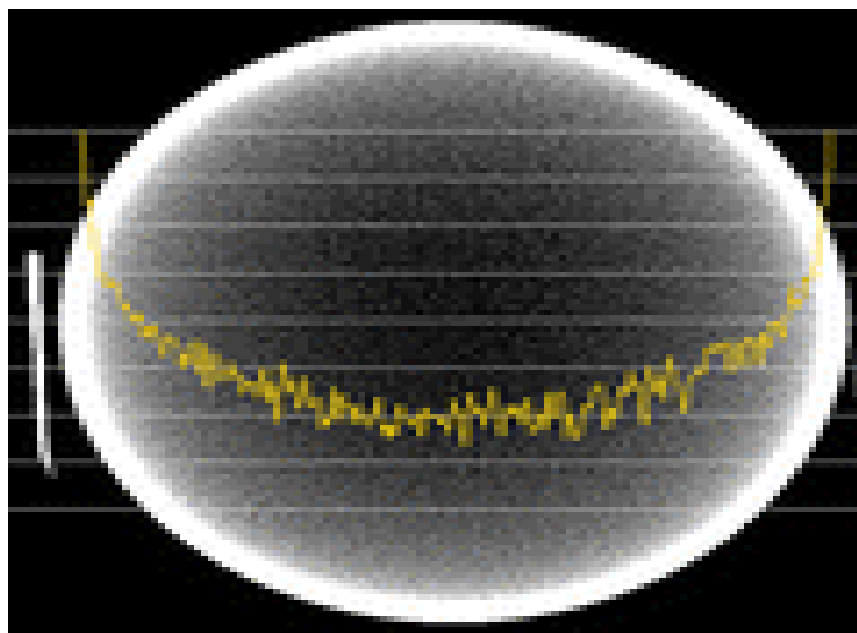
Figure (2.17) Cupping Artifacts

Is the first type of Beam Hardening artifact shown in figure (2.17) in which in it: an x-ray beam is composed of individual photons with a range of energies. As the beam passes through an object, it becomes “harder,” that is to say its mean energy increases, because the lower-energy photons are absorbed more rapidly than the higher-energy photons. Two types of artifact can result from this effect: so-called cupping artifacts and the appearance of dark bands or streaks between dense objects in the image. X rays passing through the middle portion of a uniform cylindrical phantom are hardened more than those passing through the edges because they are passing through more material. As the beam becomes harder, the rate at which it is attenuated decreases, so the beam is more intense when it reaches the detectors than would be expected if it had not been hardened. Therefore, the resultant attenuation profile differs from the ideal profile that would be obtained without beam hardening.

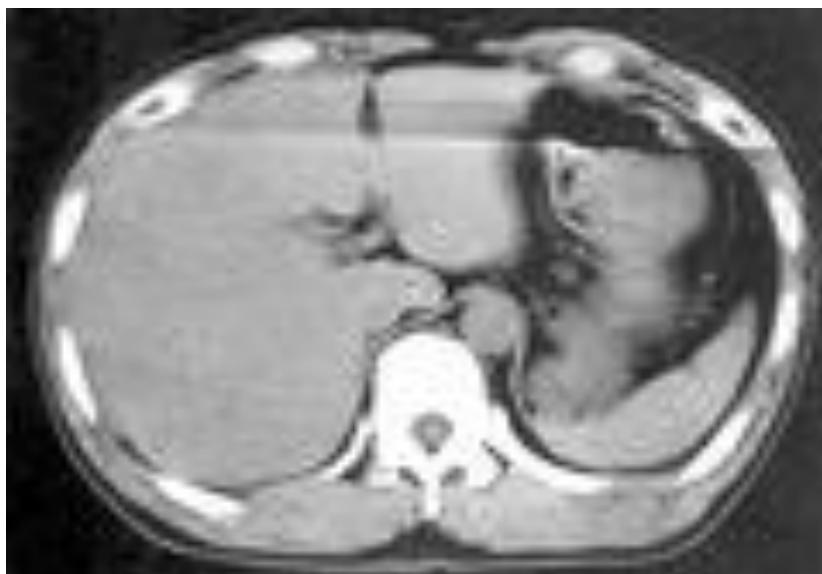
Figure (2.20) Patient Motion

Patient motion shown in figure (2.20) can cause misregistration artifacts, which usually appear as shading or streaking in the reconstructed image.

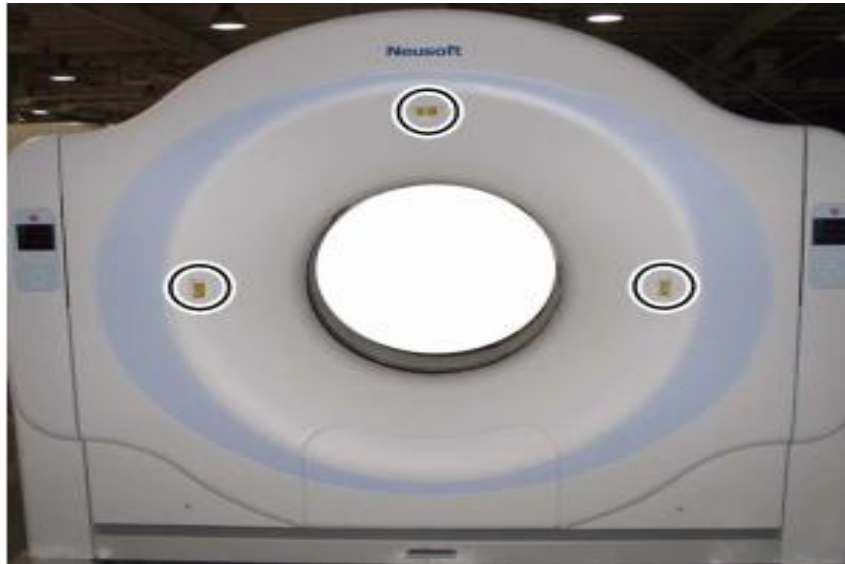
Figure (2.21): Cti Isocenter

Isocenter shown in figure (2.21) is the convergence of the three axes of rotation in radiation therapy; the intersecting point of the axis of rotation of the gantry, the collimator, and the treatment couch.

The main causes of faults in isocenter problem is happen when changing the Lamp size, light source orifice, low voltage supply or alignment. The proposed solution that should take is calibration and adjustment (move the cover, adjust the position of the position lamps on the support and re-fix them ,Fix the position lamp cover; lighten the laser position lamps to check if the
